Devil's Gate Reservoir Restoration Project Fourth Quarter Compliance Report Activities Occurring Between October 2018 and December 2018

Devil's Gate Reservoir Restoration Project
Fourth Quarter 2018 Compliance Report

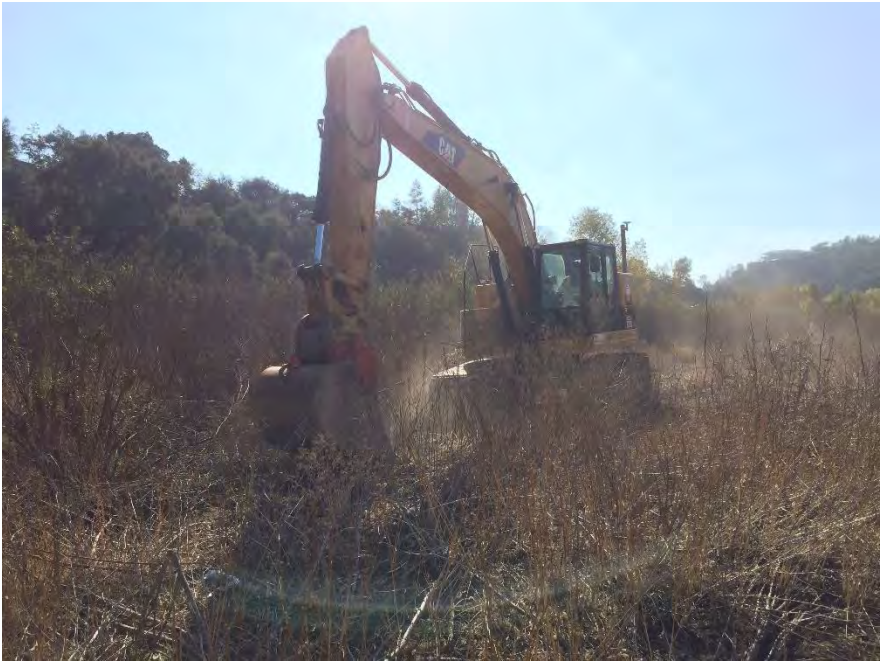
Log Entry #3 Photo C

1200 crew continued veg removal along eastern boundary. Animals relocated: western toad, alligator lizard, western fence lizard. No bio issues observed. Oak tree number 4 removed, oak tree 3 avoided. Lauren has more photos

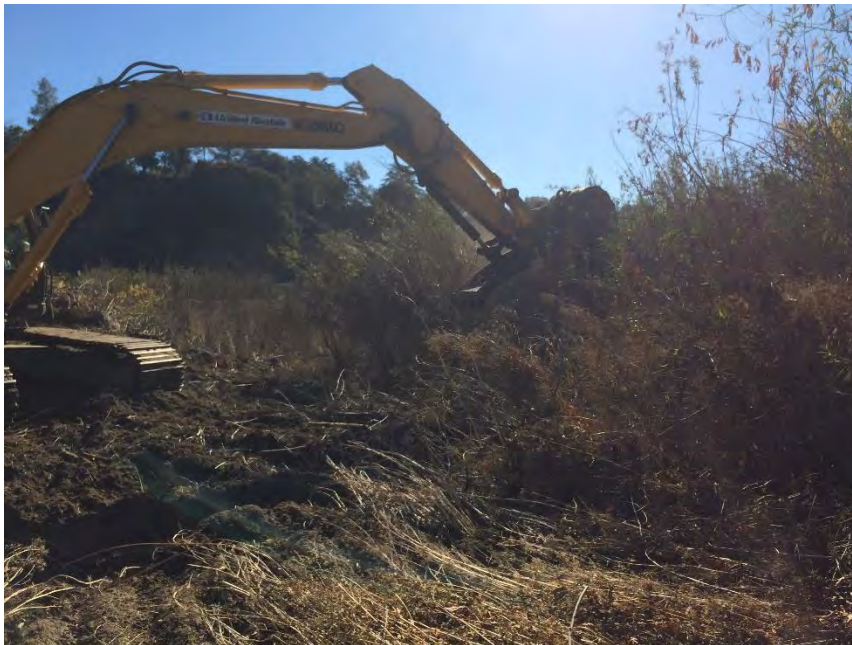
Log Entry #2 Photo A

1200. Restarted veg clearing. Nudged bat trees, none observed leaving. Felled bat trees.
