February 16, 2024  
2017-116.006

**Re: *Devil's Gate Reservoir Restoration Project – Phase 3 Restoration Qualitative Monitoring Conducted on December 22, 2023***

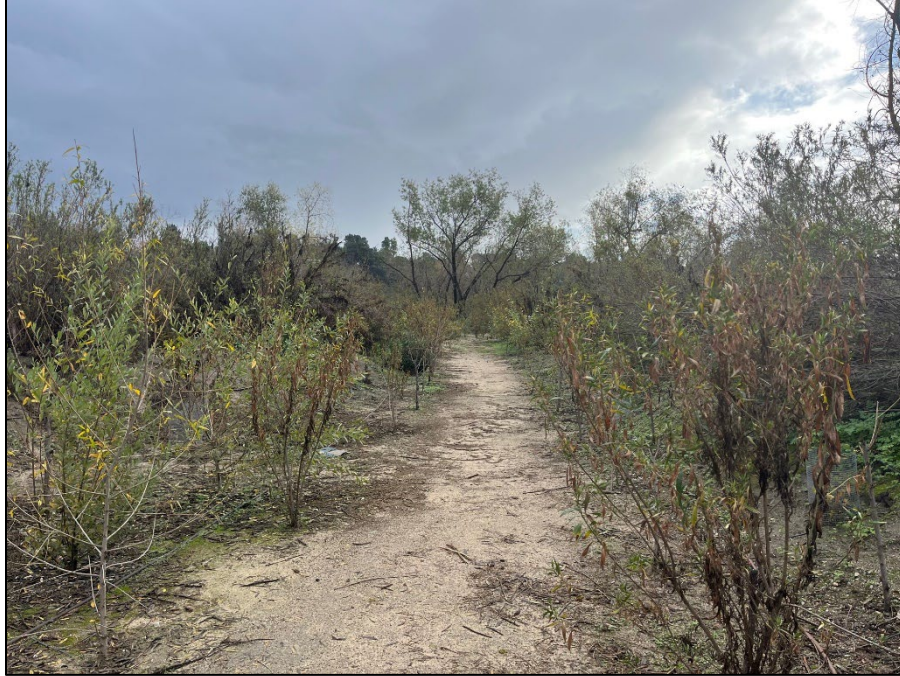
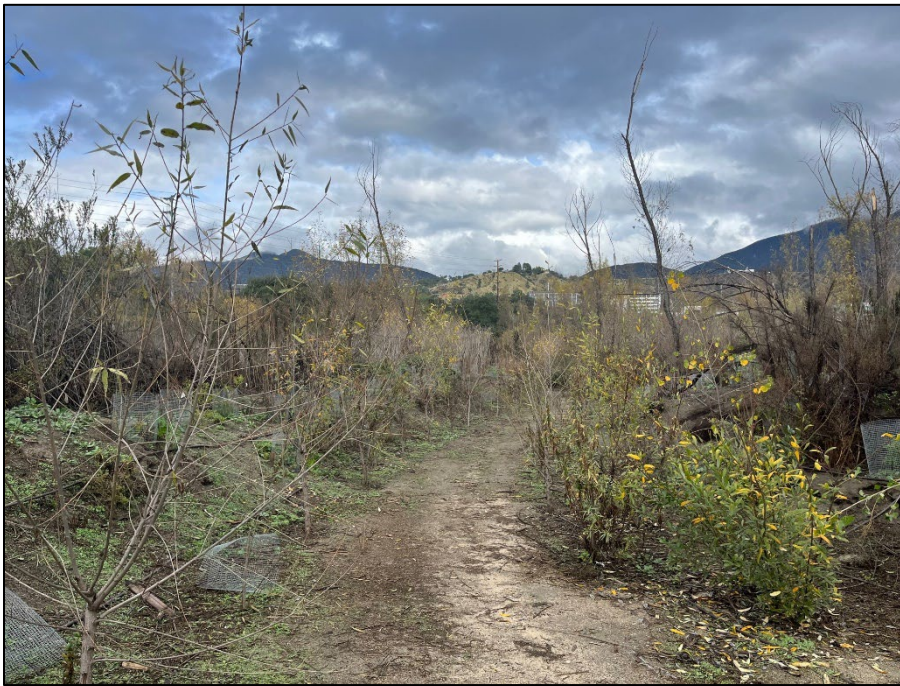
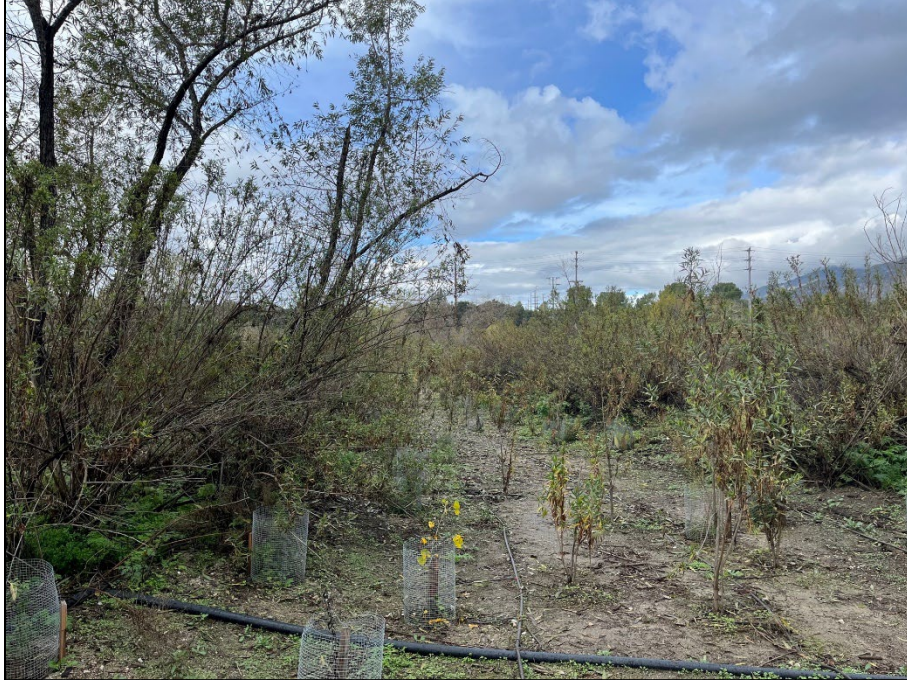
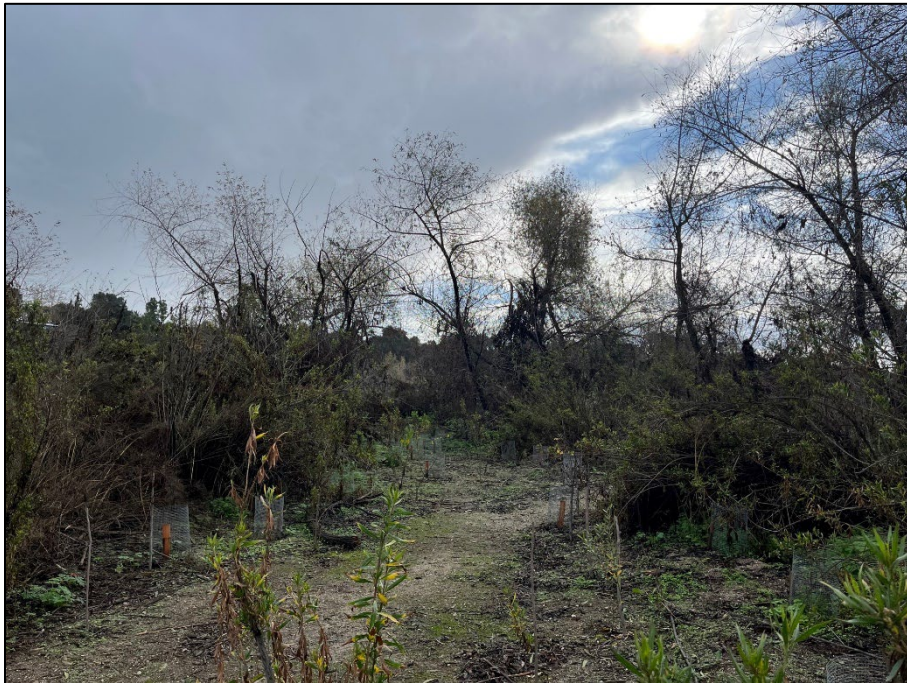
The overall health of the container plants in DG-4 WOUS and DG-4 WOUS Connections was noted as being good. Approximately 10 percent of the container plants and stakes in DG-4 WOUS and DG-4 WOUS Connections were noted as showing varied levels of stress and a negligible amount were noted as being dead or missing. This is approximately the same percentage of plants that were showing stress during the previous monitoring visit. Stress may be occurring as a result of 1) transplant shock, 2) herbivory by rabbits or other wildlife, 3) competition from nonnative and invasive weeds, 4) misplaced emitters, or 5) recreational traffic through the mitigation areas. Formal mortality counts will be taken for DG-4 WOUS and DG-4 WOUS Connections during the 2024 quantitative monitoring and will be included in the 2024 annual reporting. The majority of the recently planted mulefat and willow (*Salix* spp.) stakes were noted as showing signs of new growth; however, it appears that some did not germinate. Some of the container plants were noted as lacking well defined basins and should have their basins properly constructed and/or repaired. The installation of plants in the DG-4 WOUS and DG-4 WOUS Connections mitigation areas appears to have been completed successfully. The current issues identified during the monitoring visit are not expected to have an effect on the continued growth of the plants in the mitigation area. Photos 1 through 4 in Appendix B document the mitigation areas during the monitoring visit.

Nonnative weed cover in DG-4 WOUS and DG-4 WOUS Connections was estimated at approximately 10 to 15 percent, which is approximately 8 to 13 percent higher than what was observed during the previous monitoring visit. Nonnative species observed included black mustard (*Brassica nigra*), poison hemlock (*Conium maculatum*), perennial pepperweed (*Lepidium latifolia*), and wand mullein (*Verbascum virgatum*). Most of the nonnative weeds observed in these mitigation areas were just starting to germinate and were not going to flower or seed. As weed abatement continues in the mitigation areas, it is anticipated that the seed bank of nonnative and invasive weeds will decrease; however, perennial pepperweed easily resprouts from rhizomatous roots that can be difficult to fully remove with hand tools.

Photo 1. Overview DG-4 WOUS & WOUS Connections

Photo 2. Overview DG-4 WOUS & WOUS Connections

Photo 3. Overview DG-4 WOUS & WOUS Connections

Photo 4. Overview DG-4 WOUS & WOUS Connections

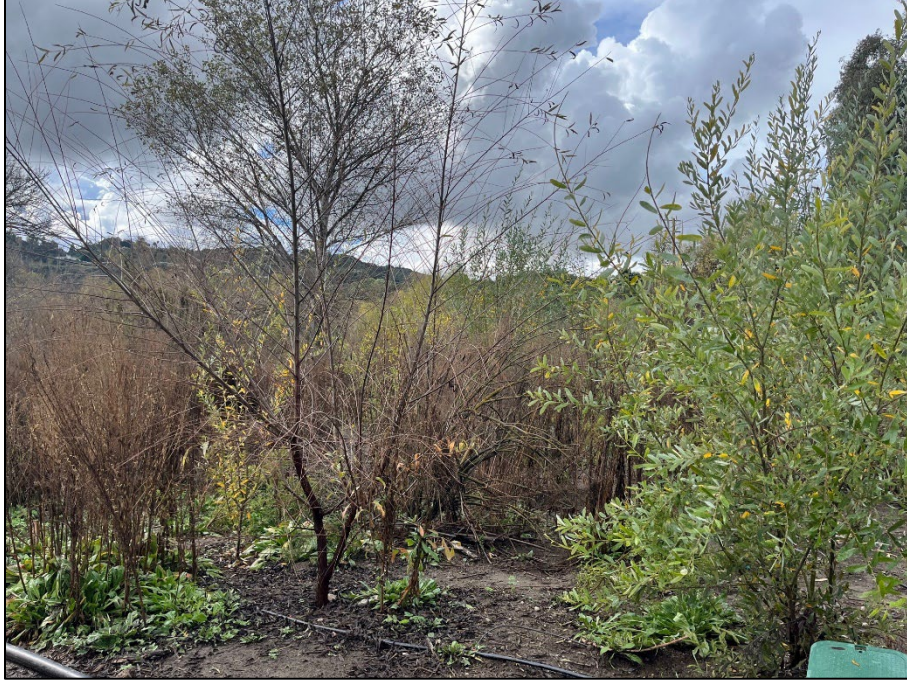
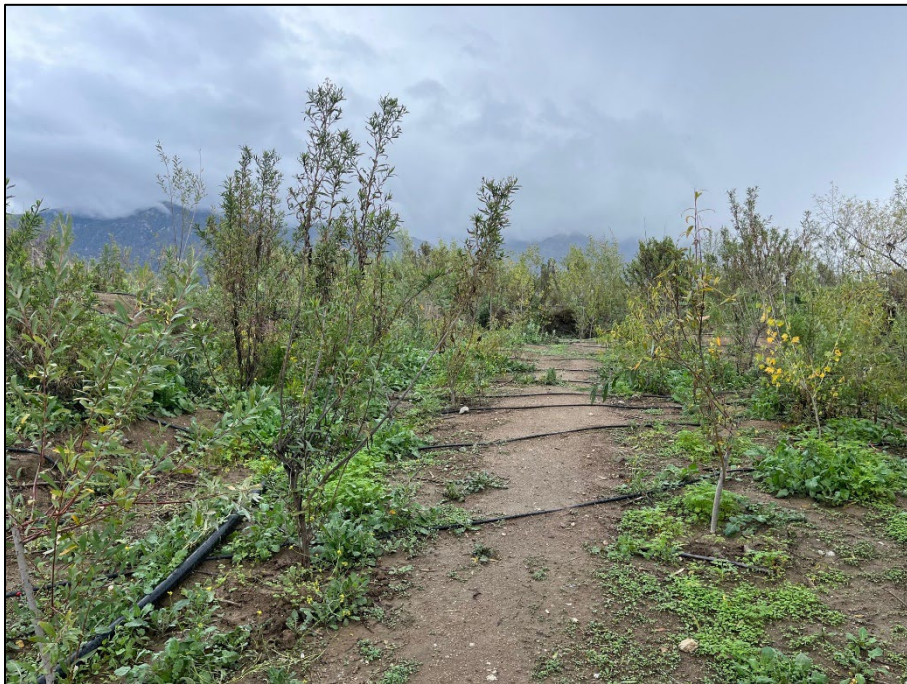
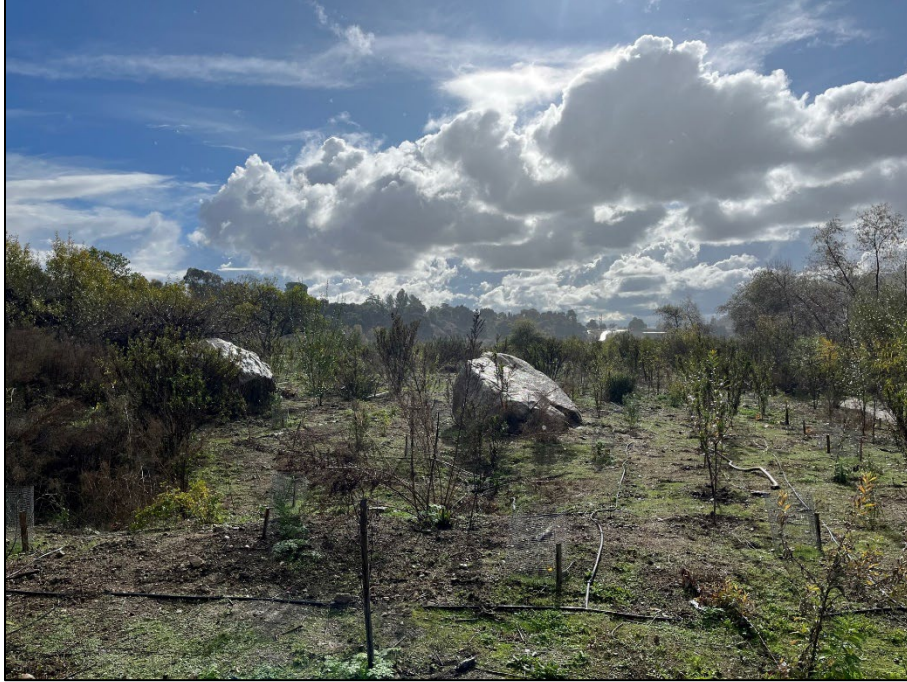
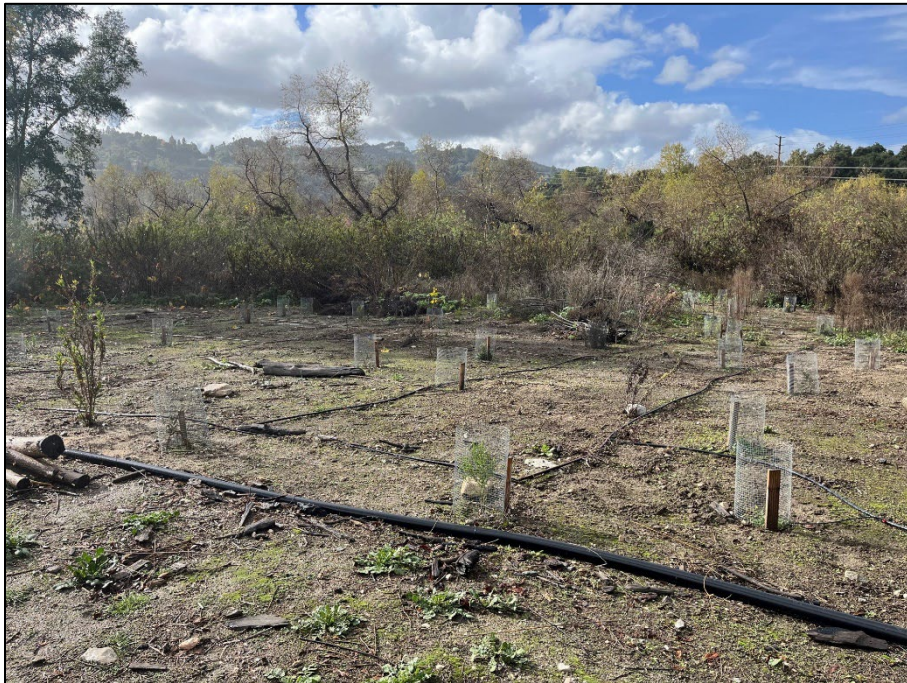
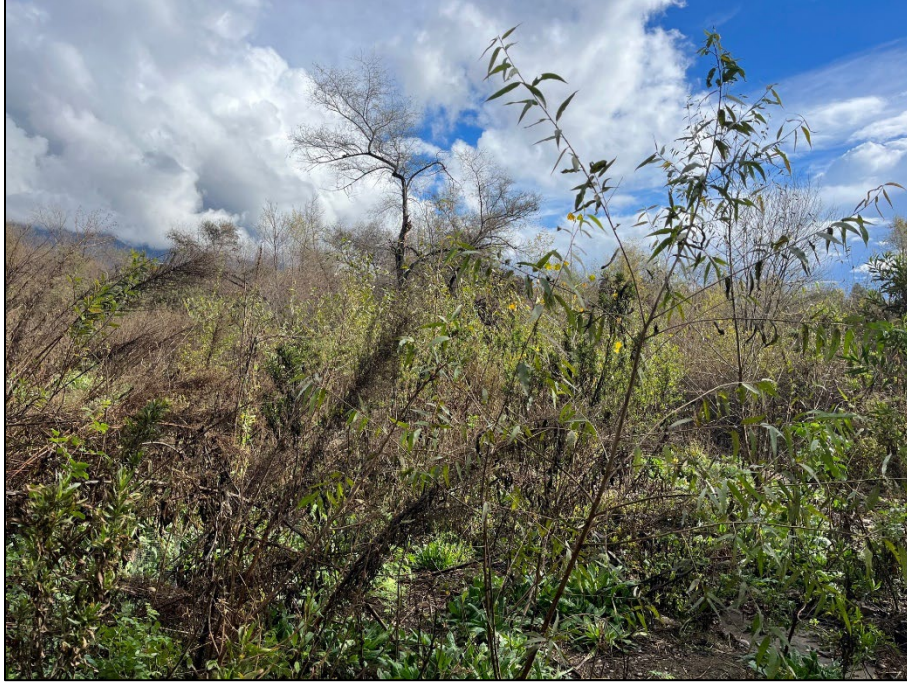
The overall health of the container plants in DG-4A was noted as being good. This included the remaining container plants from the first installation and the replacement container plants that were installed to replace the container plants and stakes planted in the middle section of DG-4A that appeared to be dead or in a condition unlikely to recover during previous monitoring visits. Stress may be occurring due to similar reasons described for DG-4 WOUS and DG-4 WOUS Connections. It should also be noted that a portion of DG-4A was inundated for two short periods of time during January and February of 2023; however, the inundation does not appear to have contributed to higher levels of stress or mortality in these areas. Formal mortality counts will be taken for DG-4A during the 2024 quantitative monitoring and will be included in the 2024 annual reporting. The majority of the recently planted mulefat and willow stakes were noted as showing signs of new growth. Some of the container plants were noted as lacking well defined basins and should have their basins properly constructed and/or repaired. The installation of plants in the DG-4A mitigation area appears to have been completed successfully and the installation of the replacement container plants should increase native cover. The current issues identified during the monitoring visit are not expected to have an effect on the continued growth of the plants in the mitigation area. Photos 5 through 9 in Appendix B document the mitigation area during the monitoring visit.

Nonnative weed cover in the DG-4A mitigation area ranged from approximately 5 to 10 percent during the monitoring visit which is approximately 10 percent lower than what was observed during the previous monitoring visit. Nonnative species observed included black mustard, poison hemlock, and perennial pepperweed. Most of the nonnative weeds observed in this mitigation area were just starting to germinate; however, some of the black mustard was starting to flower and will soon go to seed. These areas should be weeded prior to seed production. As weed abatement continues in the mitigation areas, it

Photo 5. Overview DG-4A

Photo 6. Overview DG-4A

Photo 7: Overview DG-4A

Photo 8: Overview DG-4A

Photo 9: Overview DG-4A

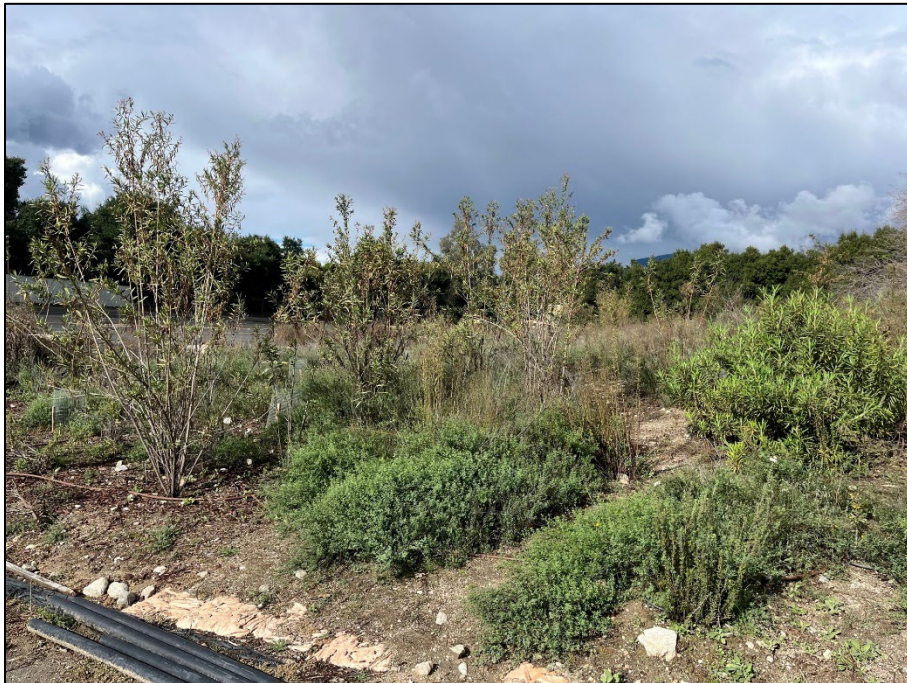
The overall health of the container plants in the Tire Wash mitigation area was noted as being good. Approximately 5 percent of the container plants were noted as showing varied levels of stress, which is approximately the same percentage of plants that were showing stress during the previous monitoring visit. This included the remaining container plants from the first installation and the replacement container plants that were installed to replace the container plants that were either missing or appeared to be dead or in a condition unlikely to recover during previous monitoring visits. Stress may be occurring due to similar reasons described for DG-4 WOUS and DG-4 WOUS Connections. Formal mortality counts will be taken for the Tire Wash during the 2024 quantitative monitoring and will be included in the 2024 annual reporting. Some of the container plants were noted as lacking well defined basins and should have their basins properly constructed and/or repaired. The installation of plants in the Tire Wash mitigation area appears to have been completed successfully. The current issues identified during the monitoring visit are not expected to have an effect on the continued growth of the plants in the mitigation area. Photo 10 in Appendix B documents the mitigation area during the monitoring visit.

Nonnative weed cover in the Tire Wash mitigation area was estimated at approximately 5 percent, which is approximately the same percentage of nonnative cover that was observed during the previous monitoring visit. Nonnative species observed included black mustard and red-stemmed filaree (*Erodium cicutarium*). Most of the nonnative weeds observed in this mitigation area were just starting to germinate; however, some of the black mustard was starting to flower and will soon go to seed. These areas should be weeded prior to seed production. As weed abatement continues in the mitigation areas, it is anticipated that the seed bank of nonnative and invasive weeds will decrease; however, perennial pepperweed easily resprouts from rhizomatous roots that can be difficult to fully remove with hand tools.

Photo 10: Overview Tire Wash

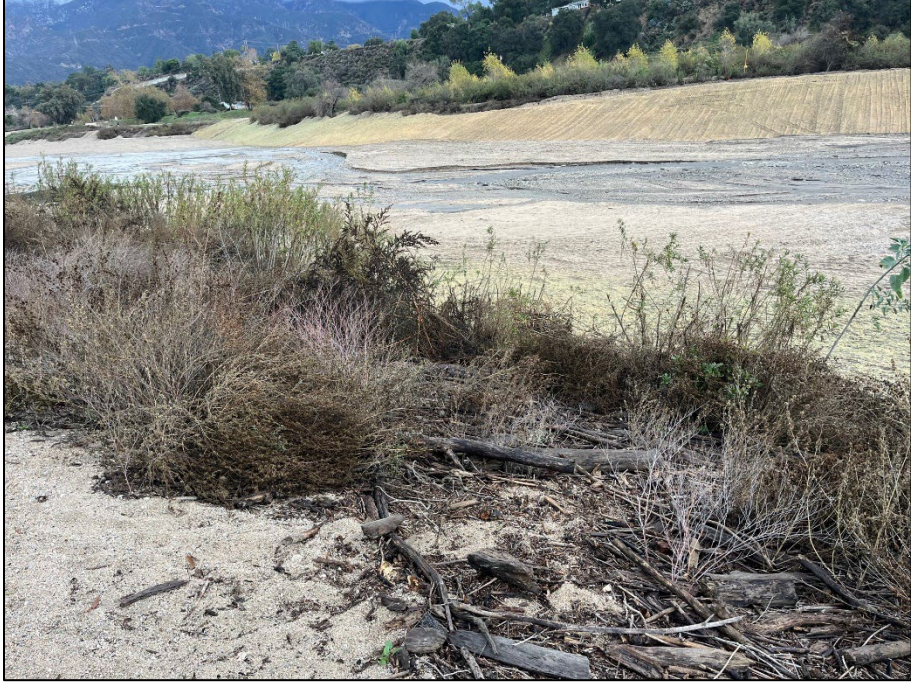
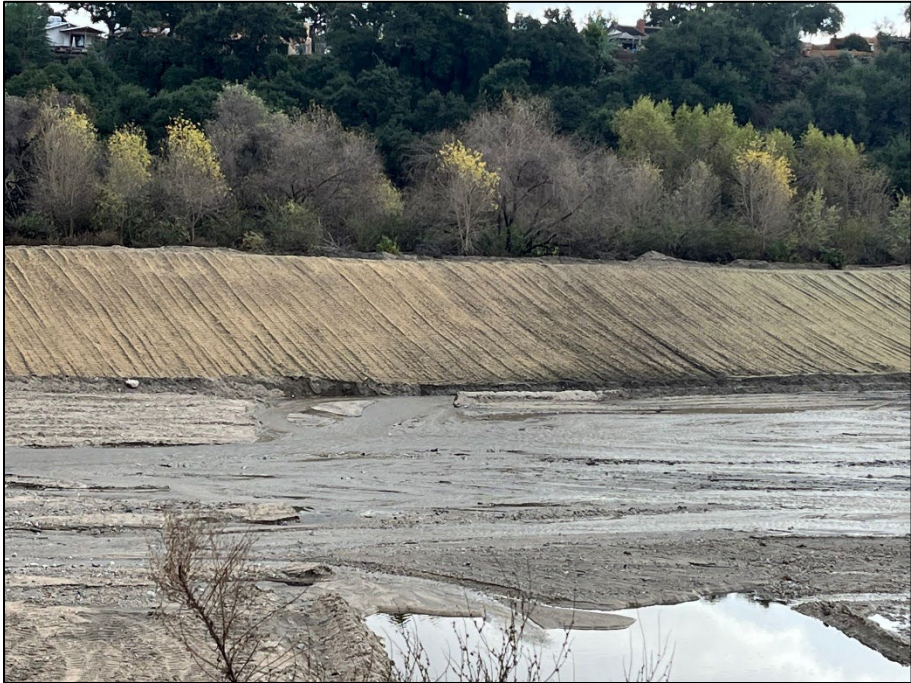
Container plants were not installed on the Side Slopes, but a portion of these areas were seeded with native plant species. Native plant growth was noted throughout the Side Slopes, likely both from natural recruitment and from seeding. Portions of the Side Slopes that were previously noted as having significant erosion that occurred as a result of heavy rainfall during the 2023 wet season and following the tropical storm that occurred in late August 2023 were noted as having been repaired during previous monitoring visits and were included in the supplemental seeding effort which was completed in November of 2023. Native plants such as annual bursage (*Ambrosia acanthicarpa*), mulefat, tall flatsedge, telegraph weed, black willow (*Salix gooddingii*), and rough cocklebur (*Xanthium strumarium*) were observed sprouting on the Side Slopes. In addition, California dodder was observed growing on some of the shrubs on the Side

Slopes, which could lead to future decline of these shrubs. Overall native cover was estimated to be approximately 45 percent during the monitoring visit; however, native cover in the areas without erosion was estimated to be 55 to 60 percent. Photos 11 and 12 in Appendix B document the Side Slopes during the monitoring visit.

Nonnative weed cover on the Side Slopes was estimated at approximately 10 to 15 percent, which is approximately 5 percent higher than the level of weed cover that was observed during the previous monitoring visit and portions of the Side Slopes had evidence of recent weed abatement. Nonnative species observed on the Side Slopes included black mustard, perennial pepperweed, tree tobacco, and castor bean (*Ricinus communis*). Most of the nonnative weeds observed in this mitigation area were just starting to germinate; however, some were starting to flower and will soon go to seed. These areas should be weeded prior to seed production. As weed abatement continues in the mitigation areas, it is anticipated that the seed bank of nonnative and invasive weeds will decrease; however, perennial pepperweed easily resprouts from rhizomatous roots that can be difficult to fully remove with hand tools.

Photo 11: Overview Side Slopes

Photo 12: Overview Side Slopes

Portions of the Side Slopes that were previously noted as having significant erosion that occurred as a result of heavy rainfall during the 2023 wet season and following the tropical storm that occurred in late August 2023 were noted as having been repaired during previous monitoring visits and were included in the supplemental seeding effort which was completed in November of 2023. As more perennial plants become established on the Side Slopes, erosion should become less of an issue; however, action will need to be taken to repair the damage caused by the erosion and measures should be taken to reduce damage from erosion in the future. During future monitoring events, erosion should continue to be monitored in all planted areas and if warranted, erosion Best Management Practices should be installed in appropriate areas. This may only require the installation of straw wattles at select sites to prevent existing rills from becoming larger.
