Devil's Gate Reservoir Restoration Project Fourth Quarter Compliance Report Activities Occurring Between October 2018 and December 2018

Devil's Gate Reservoir Restoration Project
Fourth Quarter 2018 Compliance Report

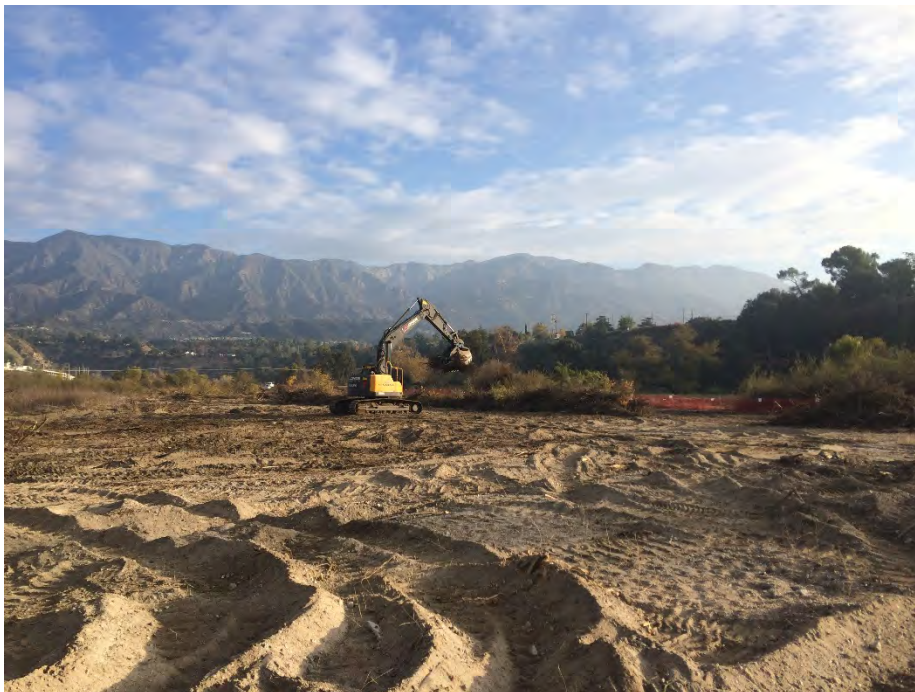
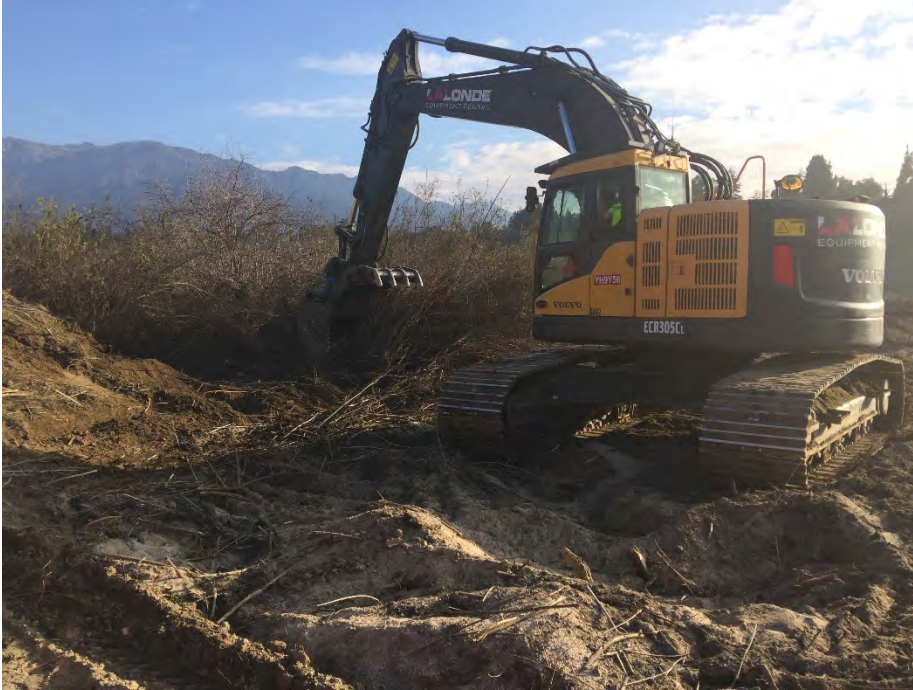
Log Entry #1 Photo A

0730: Provided wrap training to three job land clearing personnel.0745: vegetation removal on northeast end. One excavator. no special status species observed. Operator Scott.One western toad relocated. No mortalities.

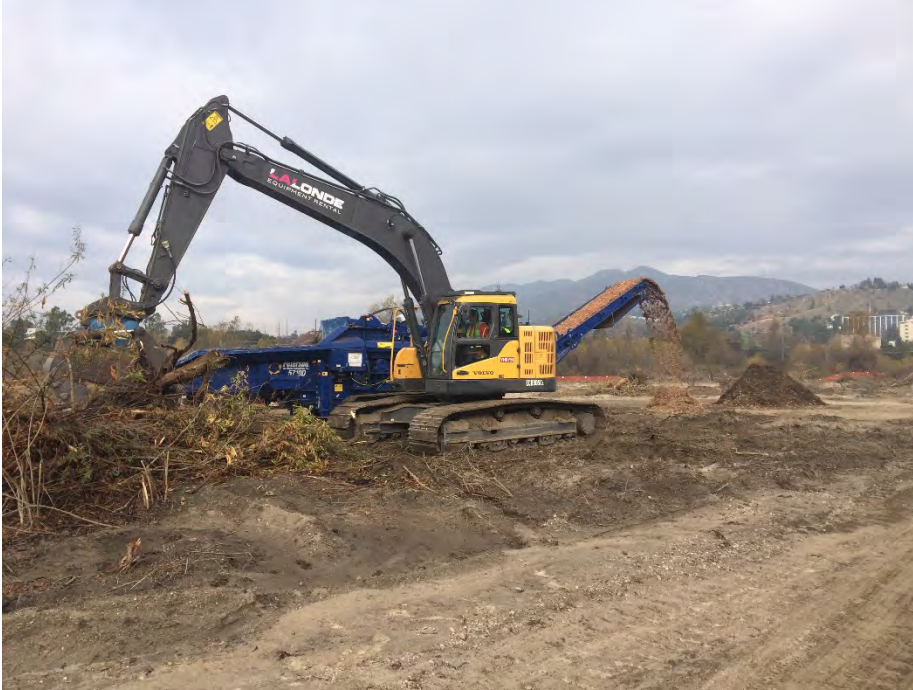
Log Entry #2 Photo A

0900: 1 excavator loading spoils into chipper. No special status species observed. Scott and Rick operators. 1 western toad relocated. Three cottontail rabbits safely flushed. 1 mice relocated.

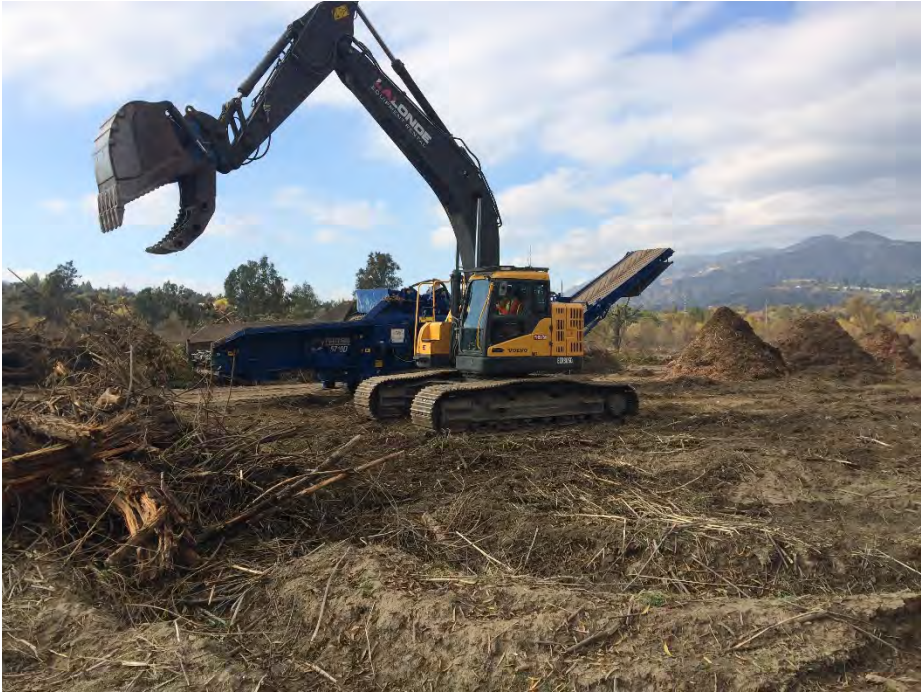
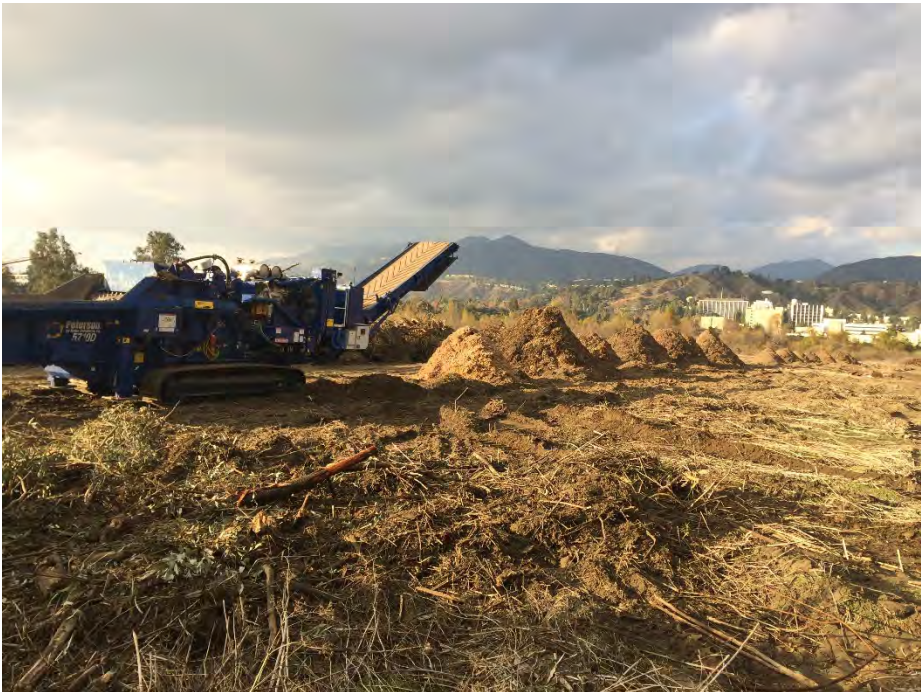
Log Entry #3 Photo A

12:30 resumed work with excavator and chipper. Scott and Rick still operating. Relocated one ca kingsnake.

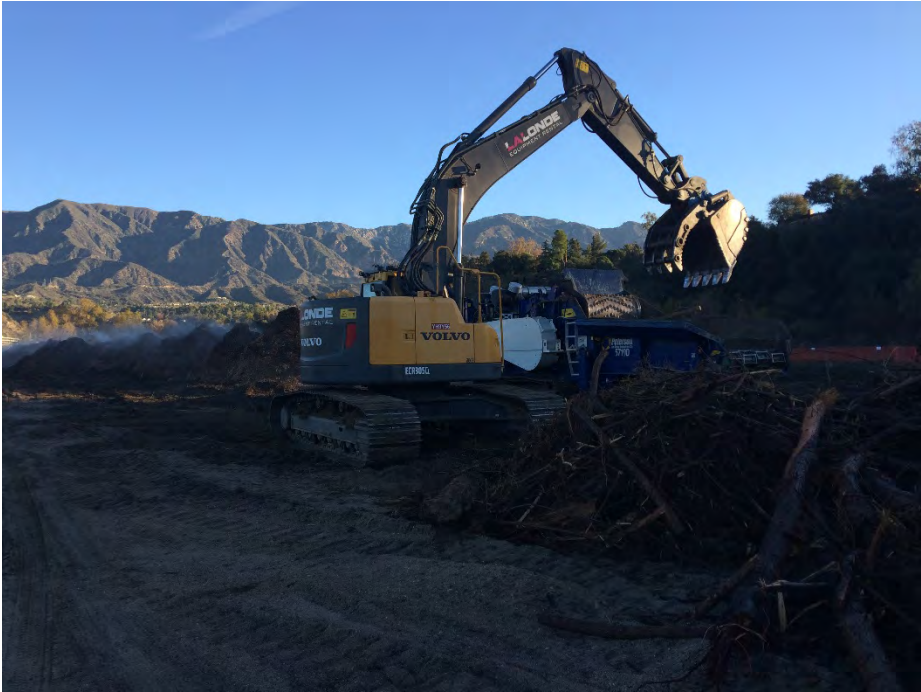
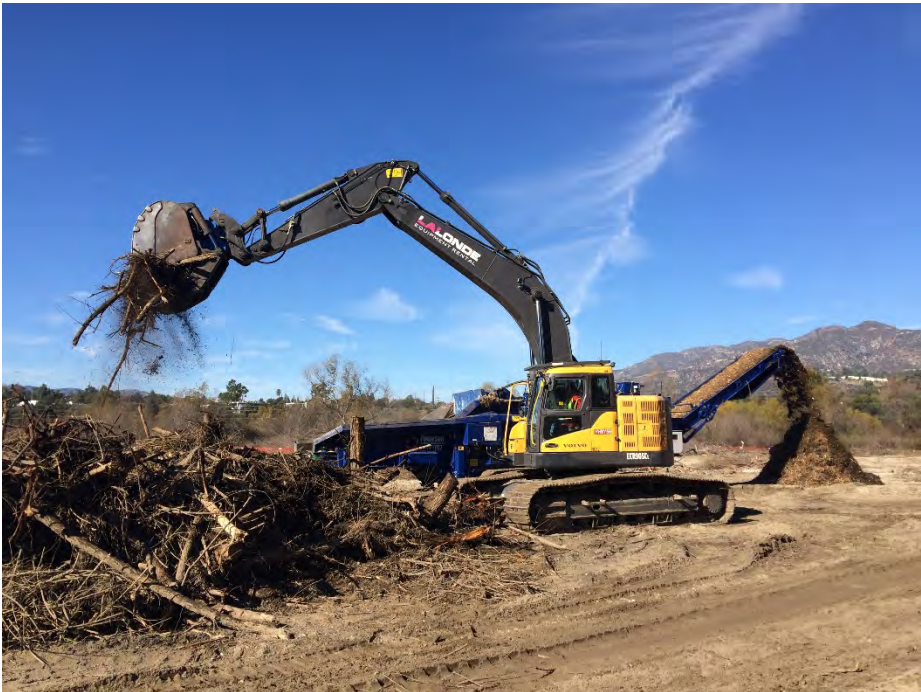
Log Entry #2 Photo A

0750- monitored Scott on excavator loading veg spoils into chipper. Chipper operated by Rick. 4 wood rats safely flushed from spoils. No mortalities observed. No issues observed.

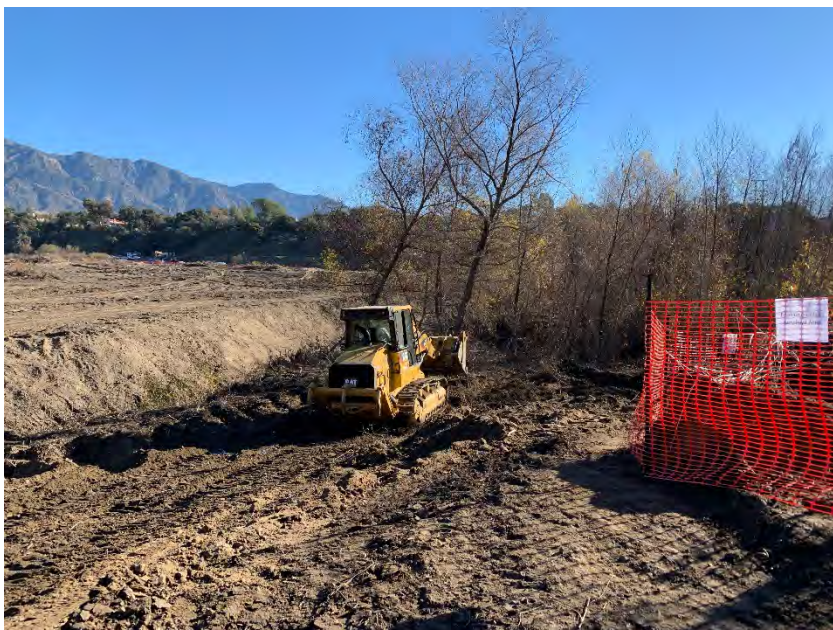
Log Entry #2 Photo A

0820, monitored vegetation clearing at the southern end of the site.

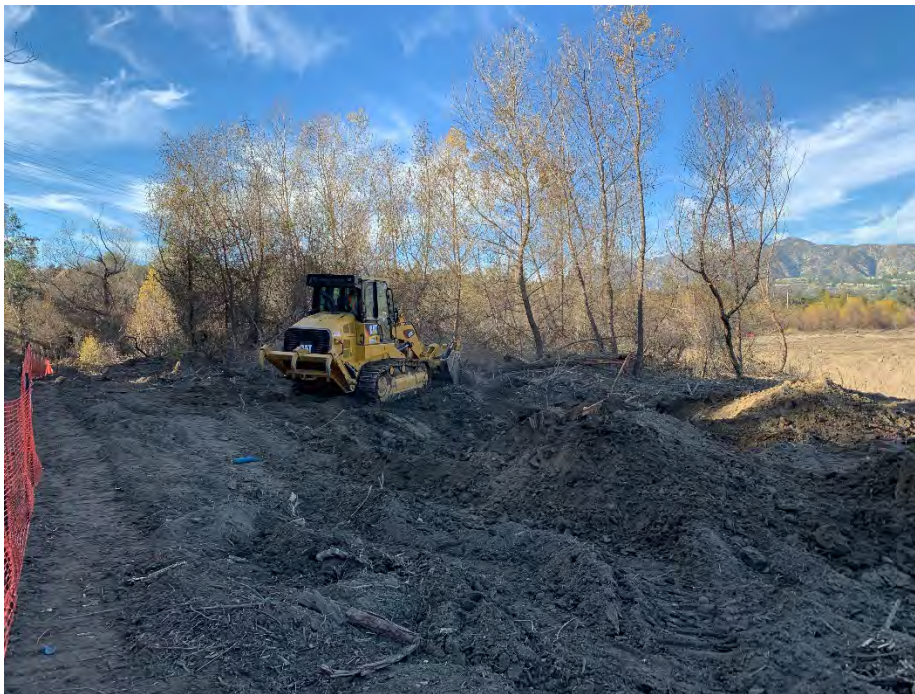
Log Entry #2 Photo A

0755- monitored vegetation removal on the south end. Relocated 1 Baja California tree frog, 1 black rat, and 1 desert woodrat.

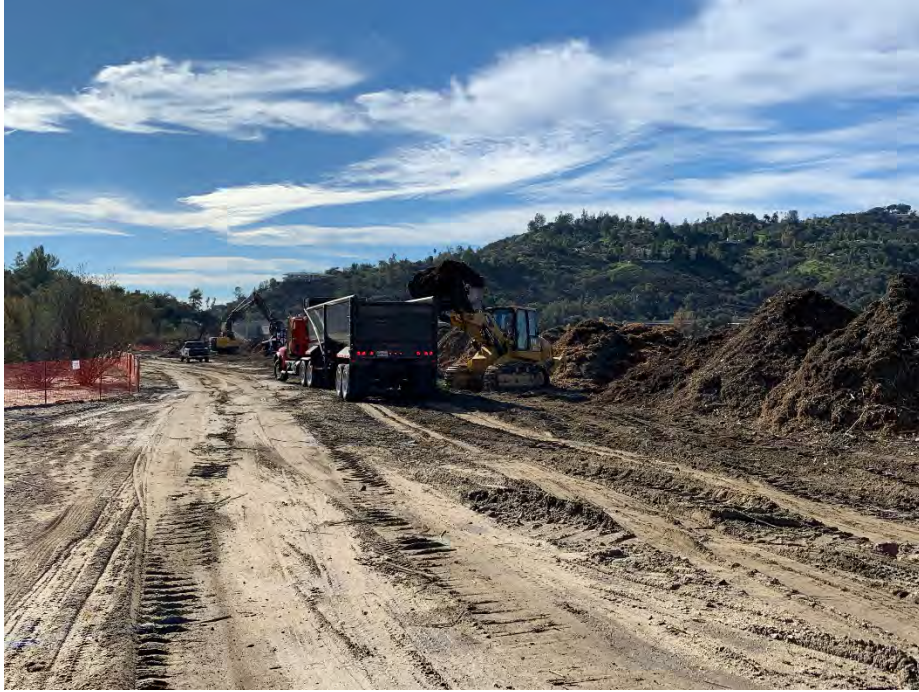
Log Entry #3 Photo A

1055- monitored track loader loading chipped vegetation into a truck to be hauled off site.

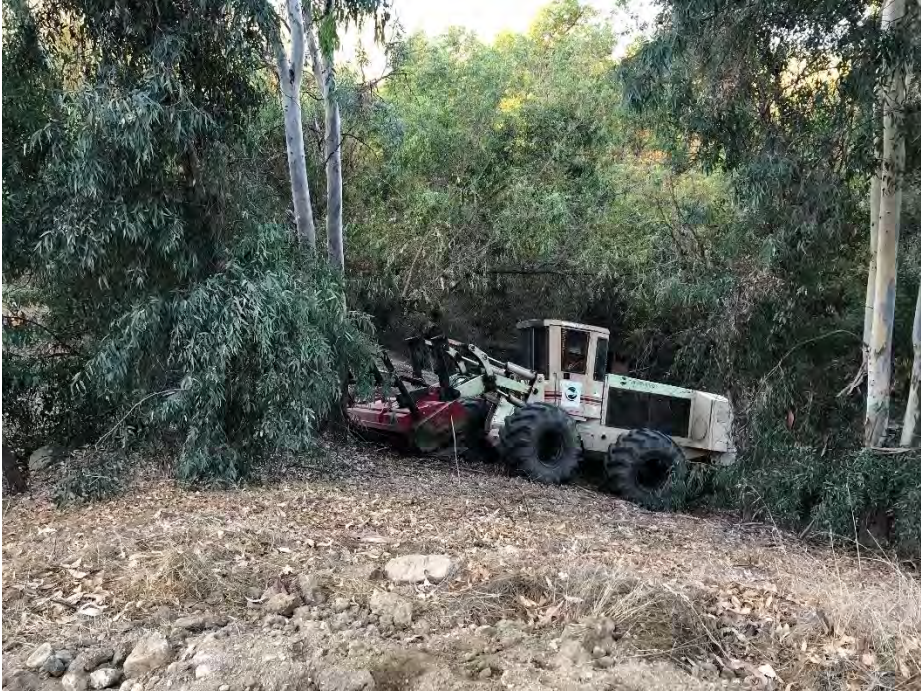
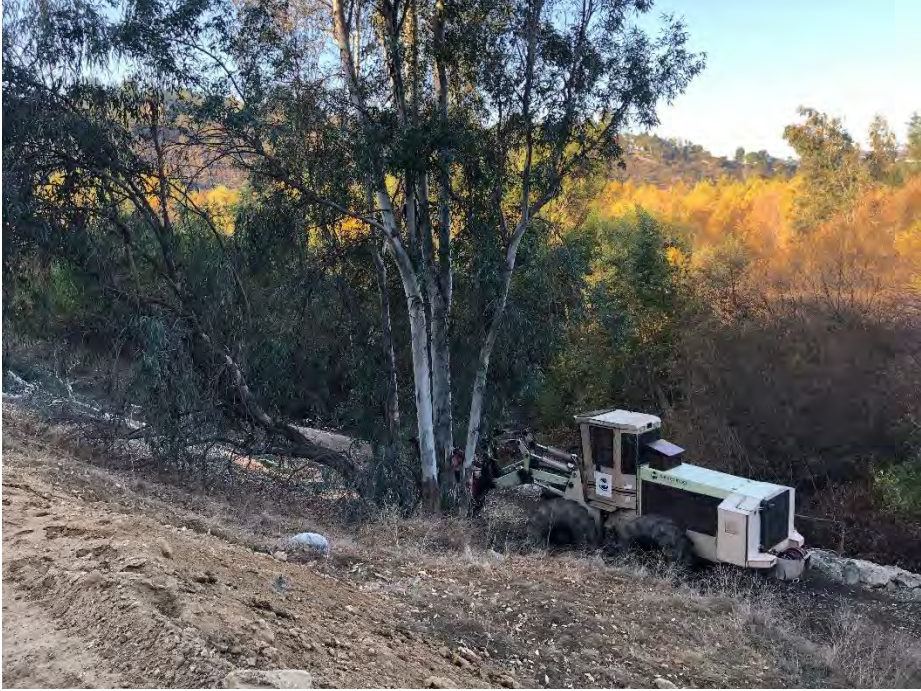
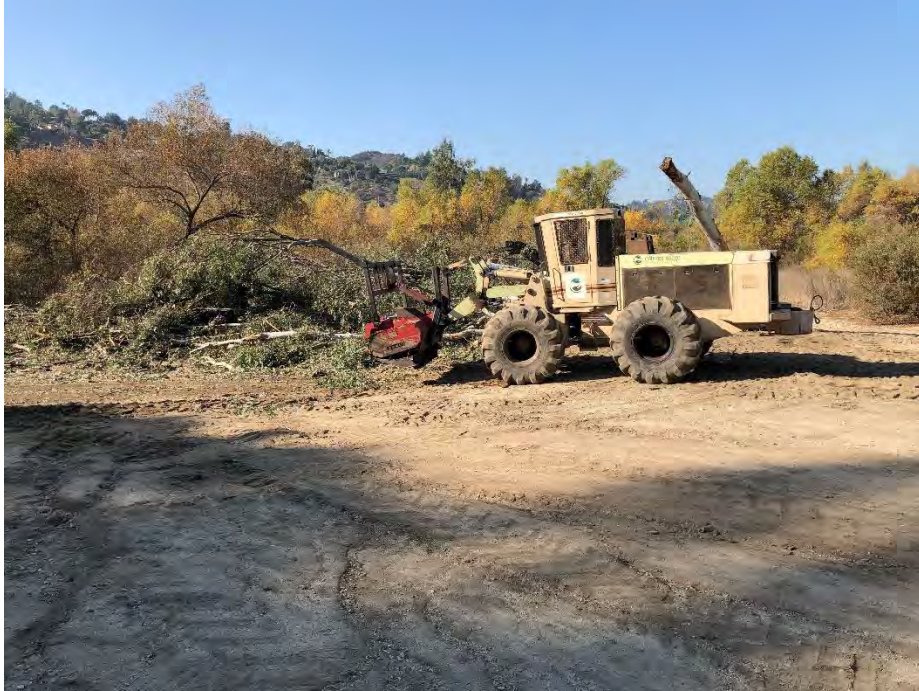
Log Entry #1 Photo A

0745, eucalyptus tree/bat habitat removal monitoring. No bats observed.

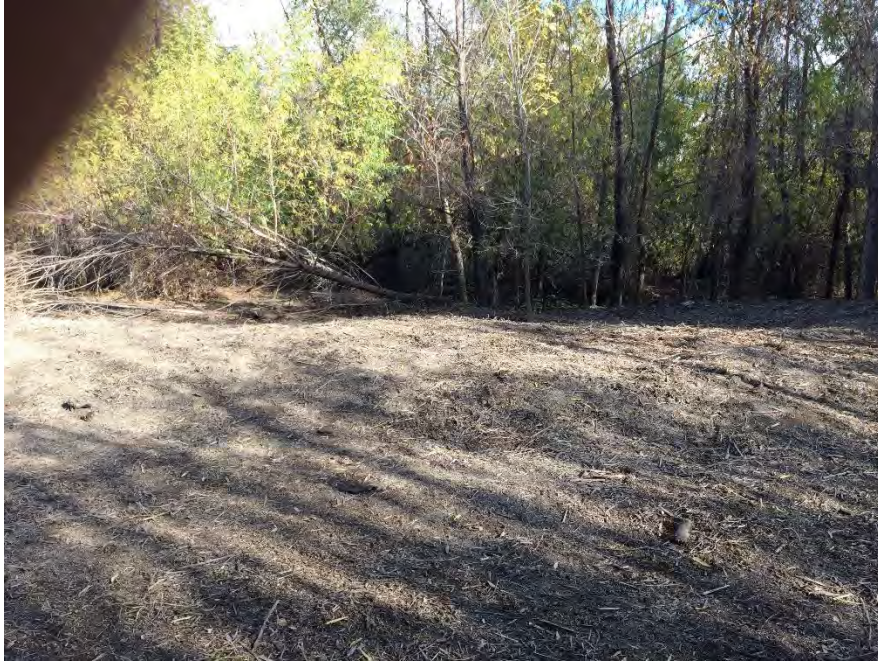
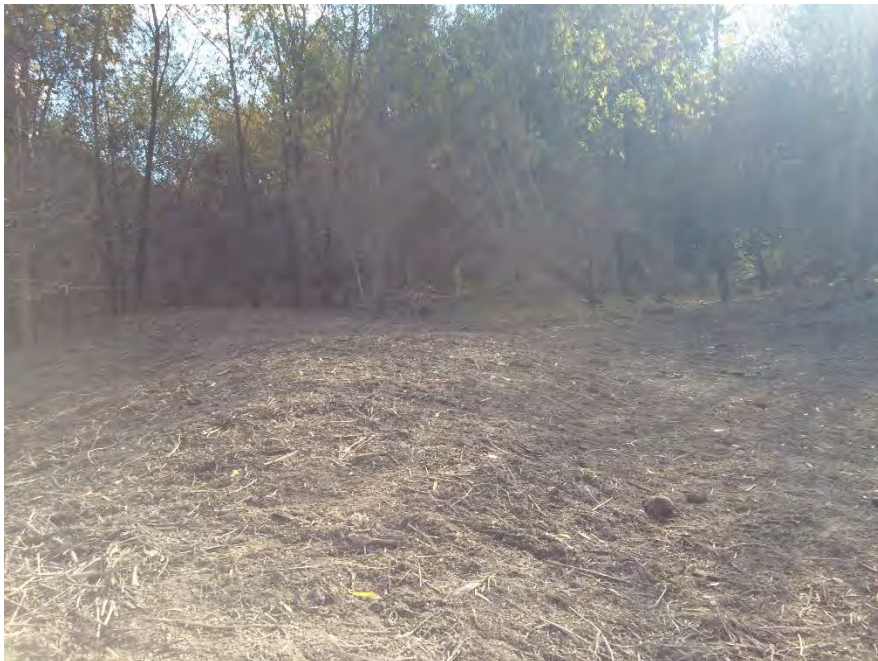
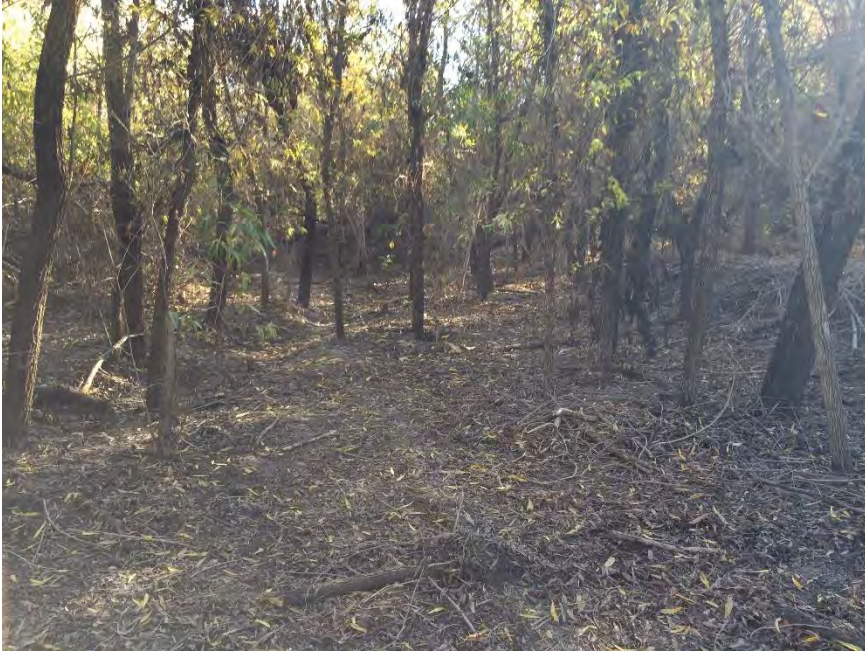
Log Entry #4 Photo A

1200 returned to work, vegetation clearing continued. 1230, possible sighting of yellow rumped warbler by worker. Not seen by biologist.

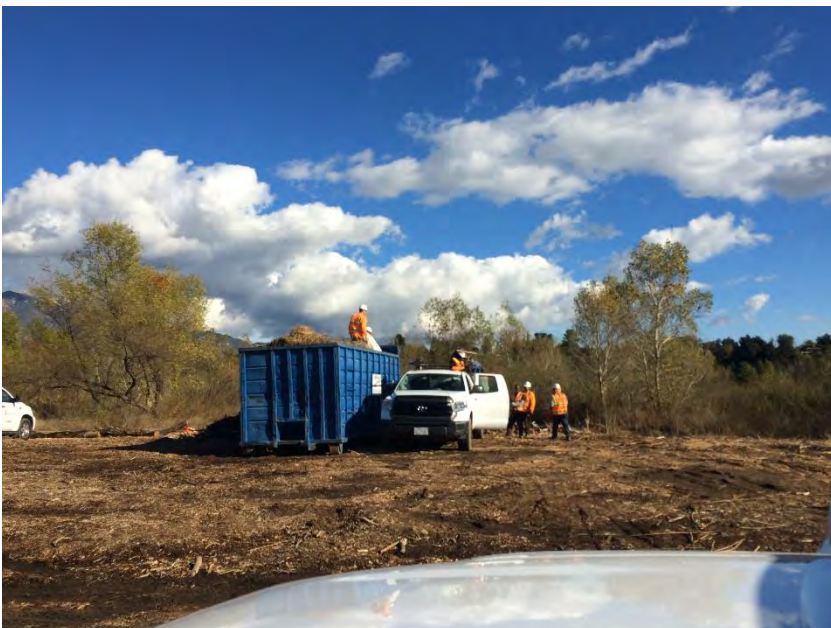
Log Entry #5 Photo A

1412. Crew managed to fit all veg material in dumpster, no black bags needed. Crew finishing up for the day, gathering equipment. No more veg cleanup for day. Biologist left site at 1430.

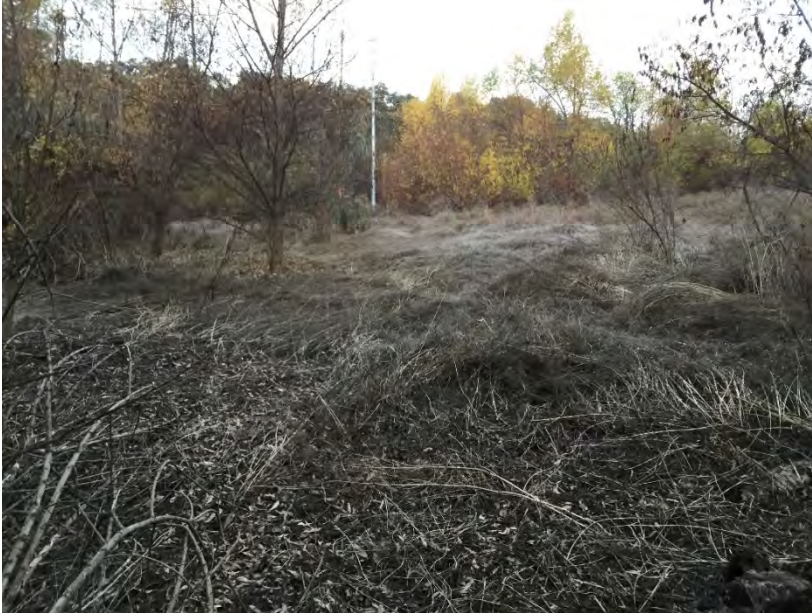
Log Entry #1 Photo A

0705- swept site prior to work. No SSS observed.

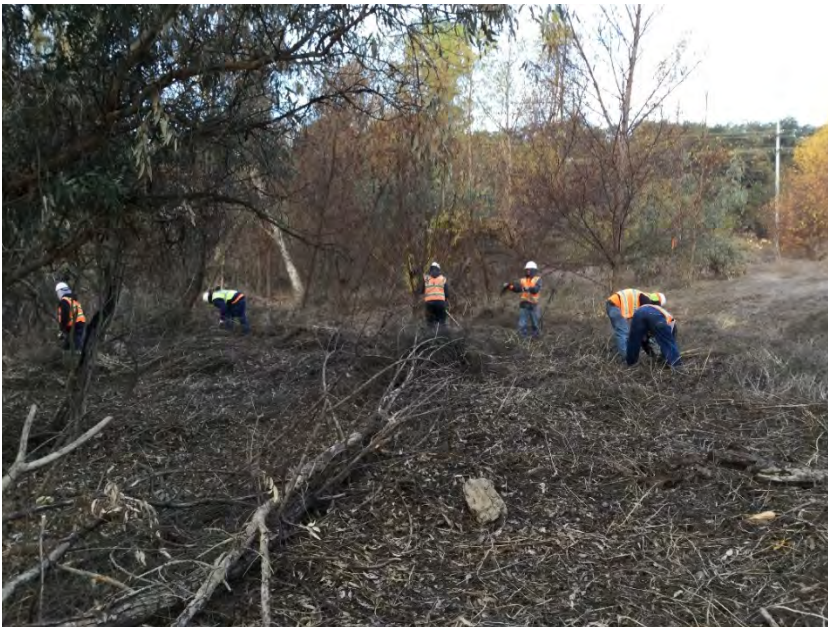
Log Entry #2 Photo A

0720- crew started restoration work through hand pulling, raking, and hoeing, non-native vegetation. Mainly LepLat and ConMac. Took lunch from 1100 to 1200.

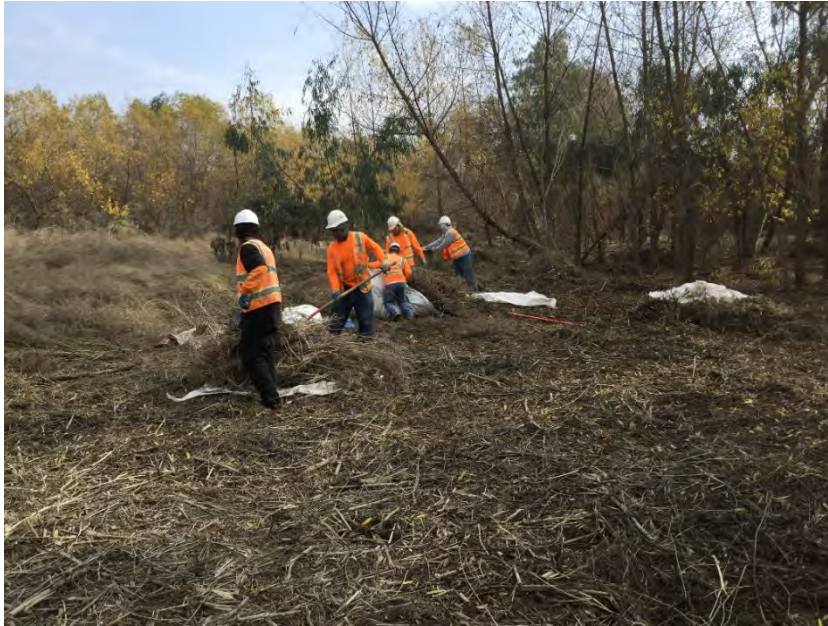
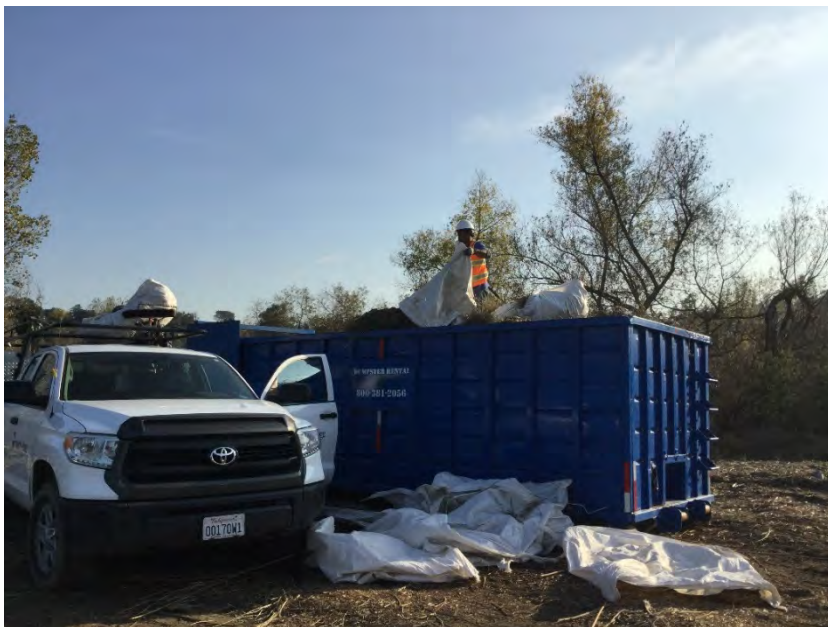
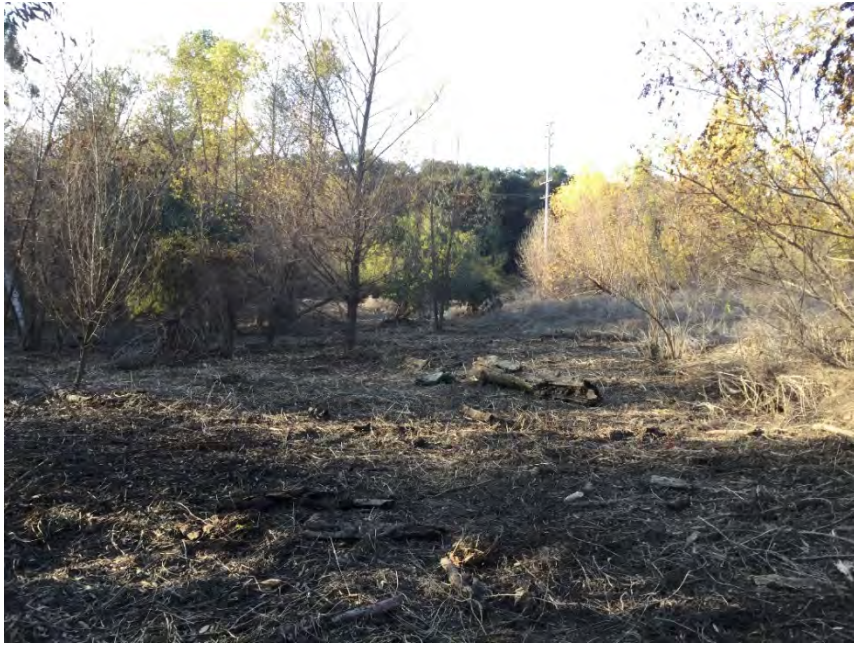
Log Entry #3 Photo A

1200- crew tarping vegetation they pulled this morning and dumping into dumpster.

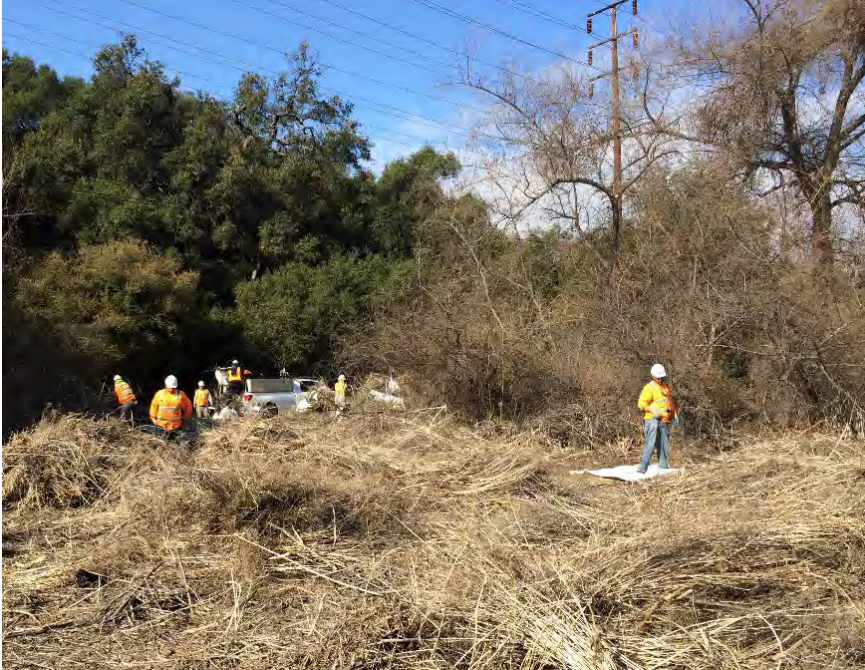
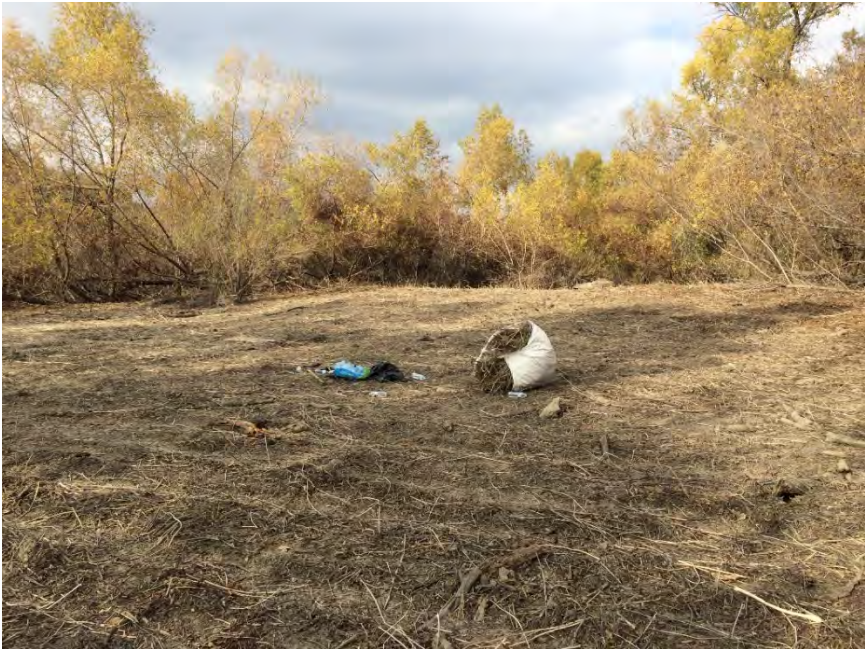
Log Entry #2 Photo A

1130 back to non-native removal. Crew trapping up what they cleaned this morning, no more actual removal of non-natives. 1500 finished cleaning up veg material and dumping in bins, biologist left site 1505.

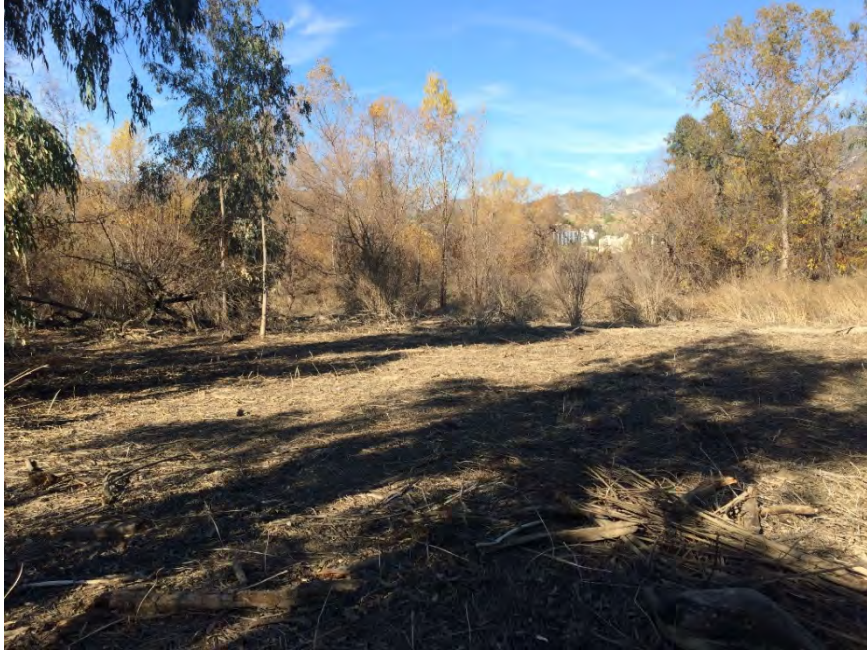
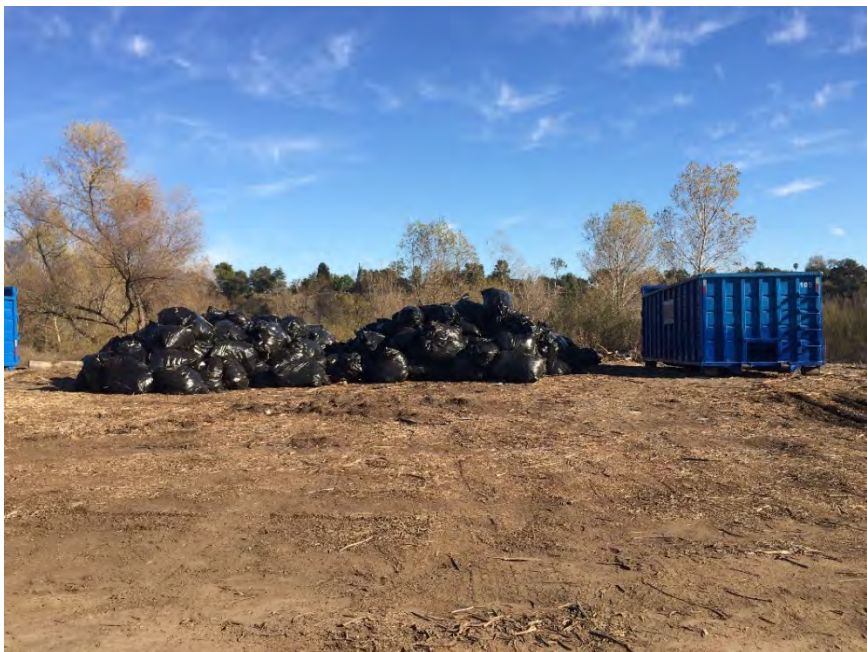
Log Entry #2 Photo A

1030 back to non-native removal. Crew picking up veg piles pulled from this morning. 1400 crew has no space in trash bins, no bin received today. Crew bagging up vegetative material and placing it near bins. Empty bins coming tomorrow.

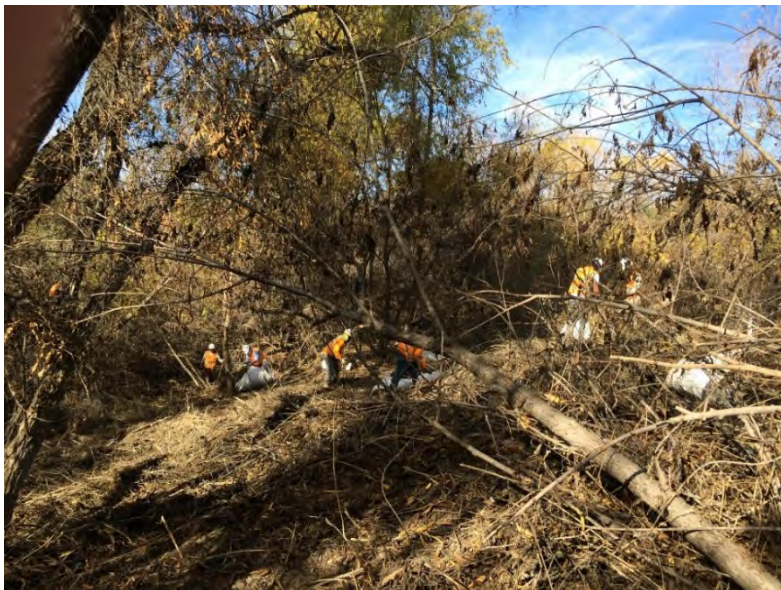
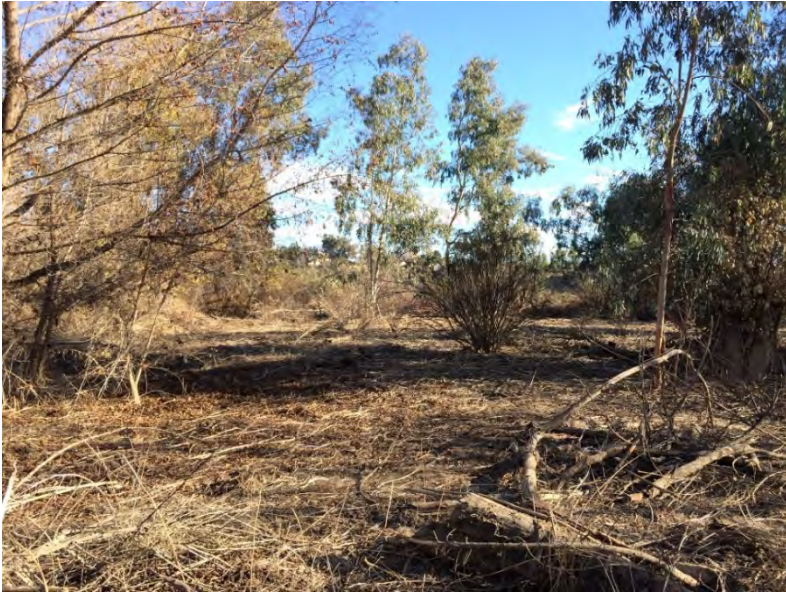
Log Entry #2 Photo A

1130 back from lunch, crew picking piles of non-native vegetation removed earlier today. Trash bin has been received so no expected delays. Conducted final sweep at 1415, biologist left site at 1425.

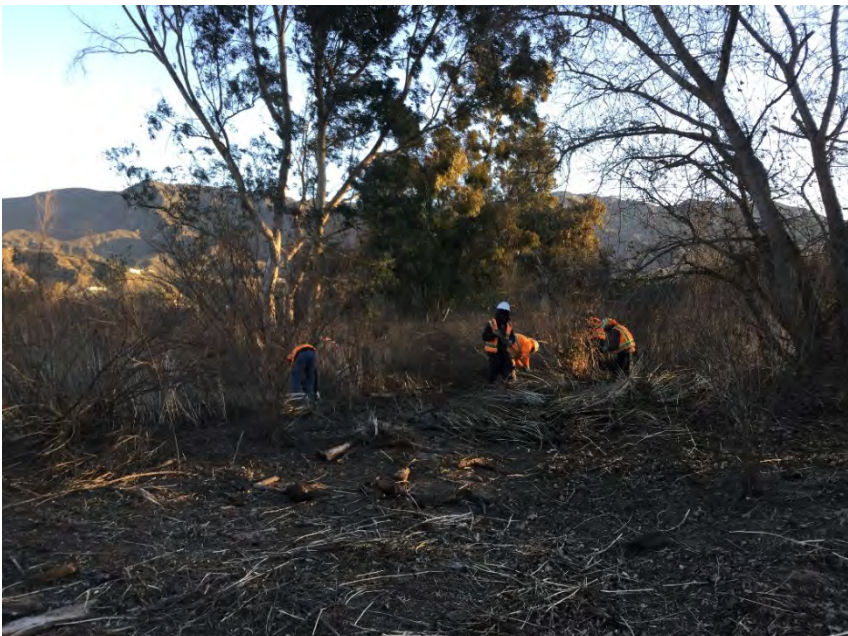
Log Entry #2 Photo A

0715- Crew started work hand pulling non-native species. No SSS observed. Lunch break at 1100.

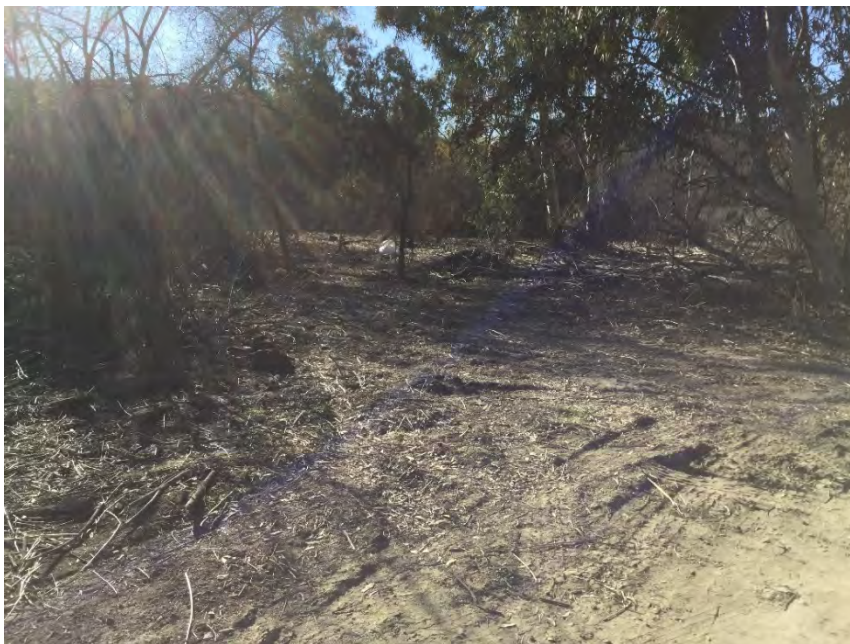
Log Entry #4 Photo A

1200- Crew raking and tarping non-natives plants they pulled this morning. No SSS observed. Crew still working when I left.
