Devil's Gate Reservoir Restoration Project Fourth Quarter Compliance Report Activities Occurring Between October 2018 and December 2018

Devil's Gate Reservoir Restoration Project
Fourth Quarter 2018 Compliance Report

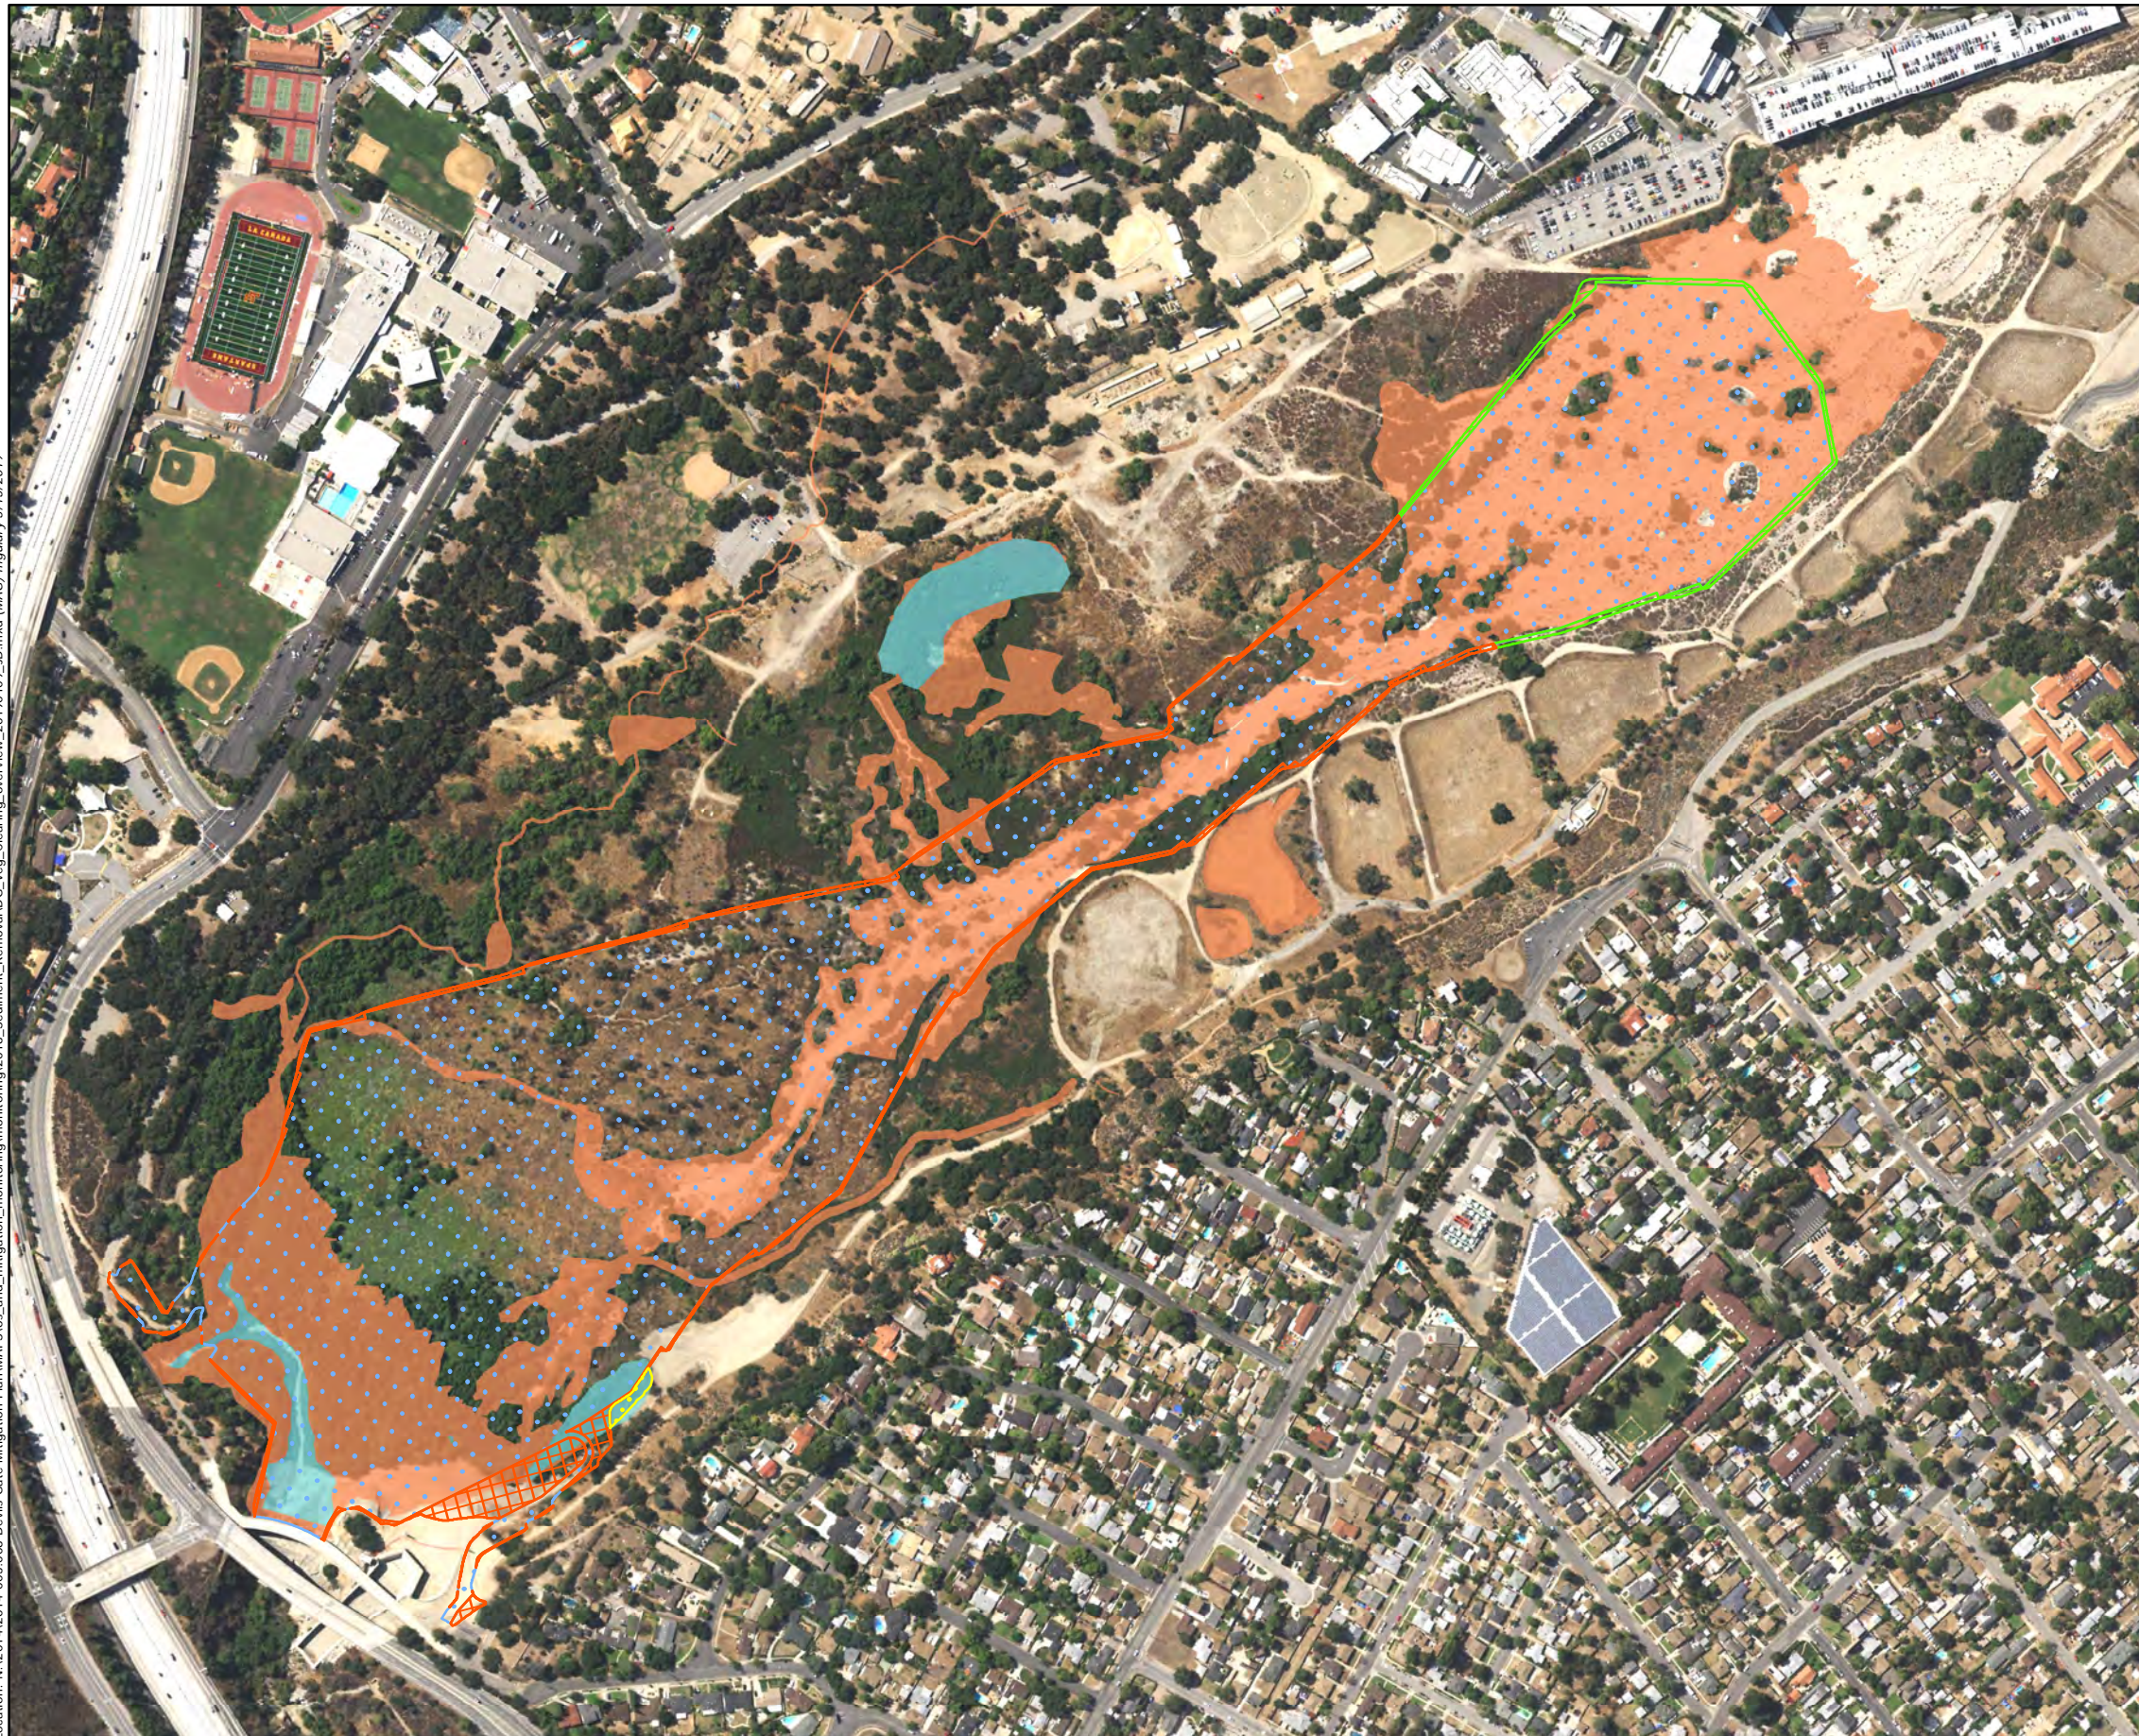
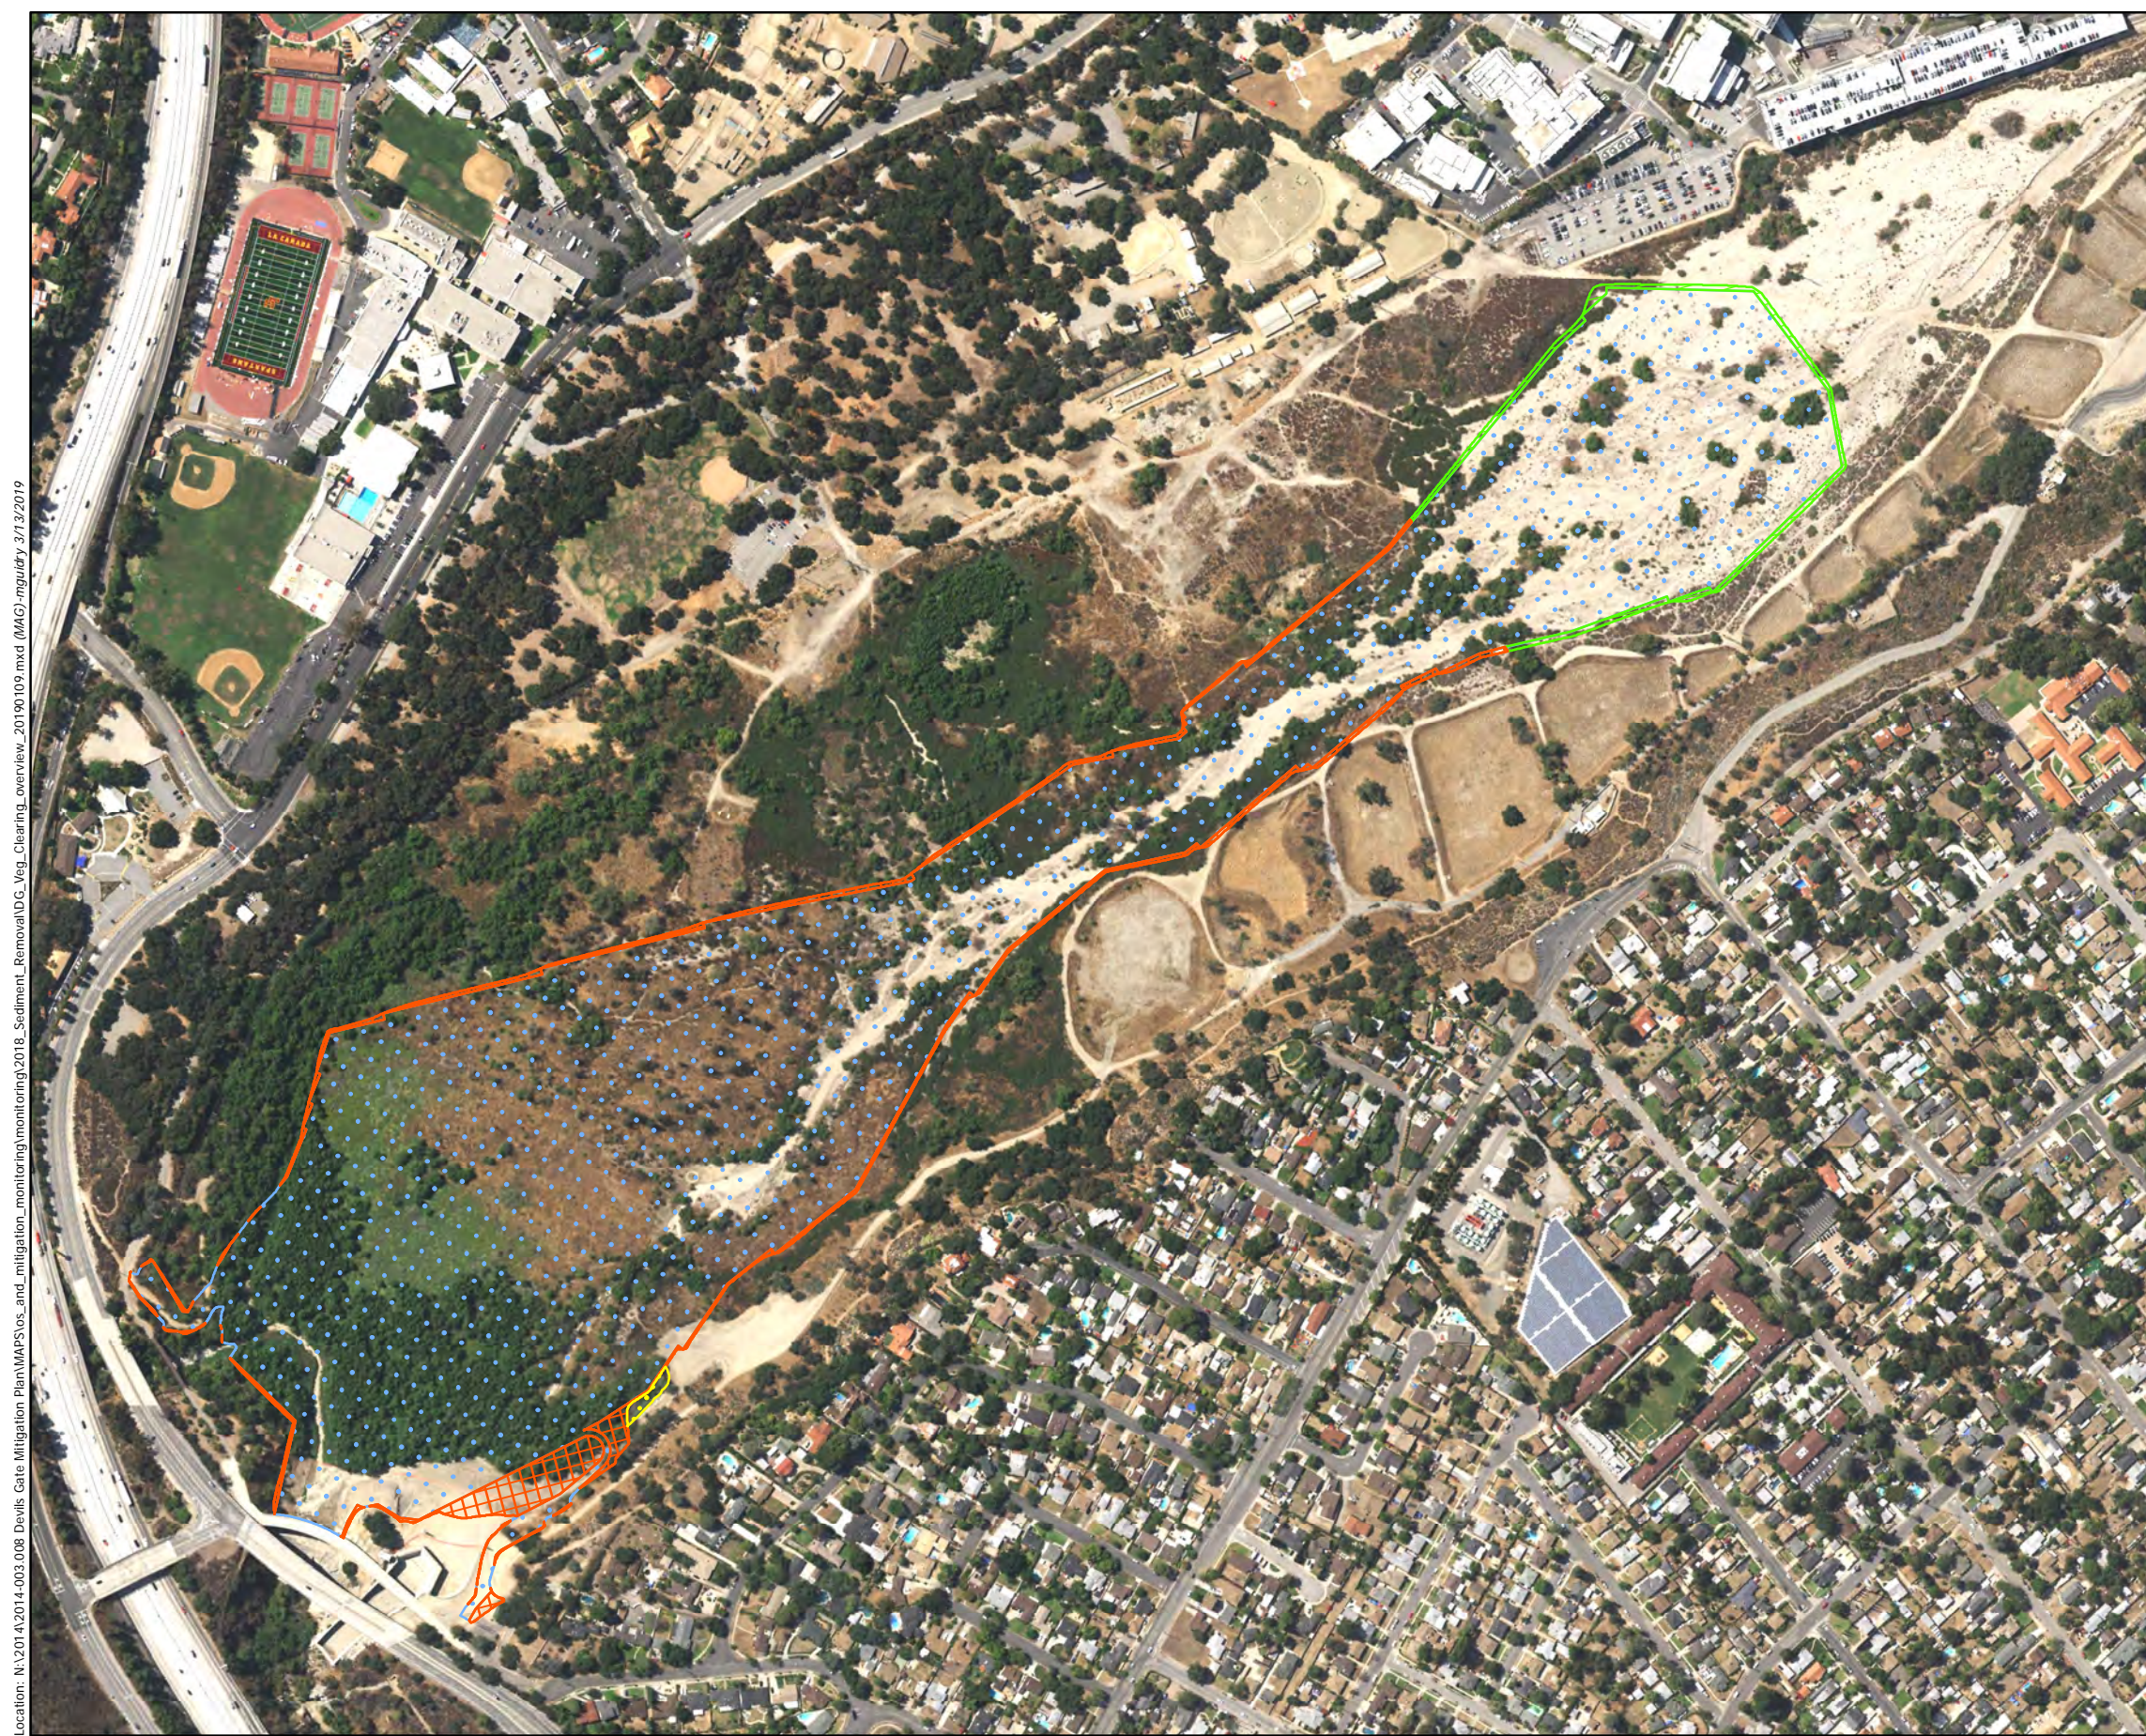
Figure 1.
Vegetation Clearing and the
Initial Sediment Removal Area

Figure 1 in Attachment 1 shows the entire Project area, the areas where the impacts occurred outside of the areas approved in the permit, the areas where future impacts may occur, and the locations of waters of the U.S. within the Project area. The differences between ECORP's limits of grading boundary and the Contractor's limits of clearing and grubbing boundary are shown in the orange and green hatched color patterns mentioned above. The discrepancies between the two boundaries are minor around most of the Initial Sediment Removal Area (ISRA) with the largest discrepancy occurring where the eastern access road intersects the area around the West Altadena Drain. The area shown in the yellow dotted pattern is where the clearing contractor cleared the vegetation outside of the clearing and grubbing limits.

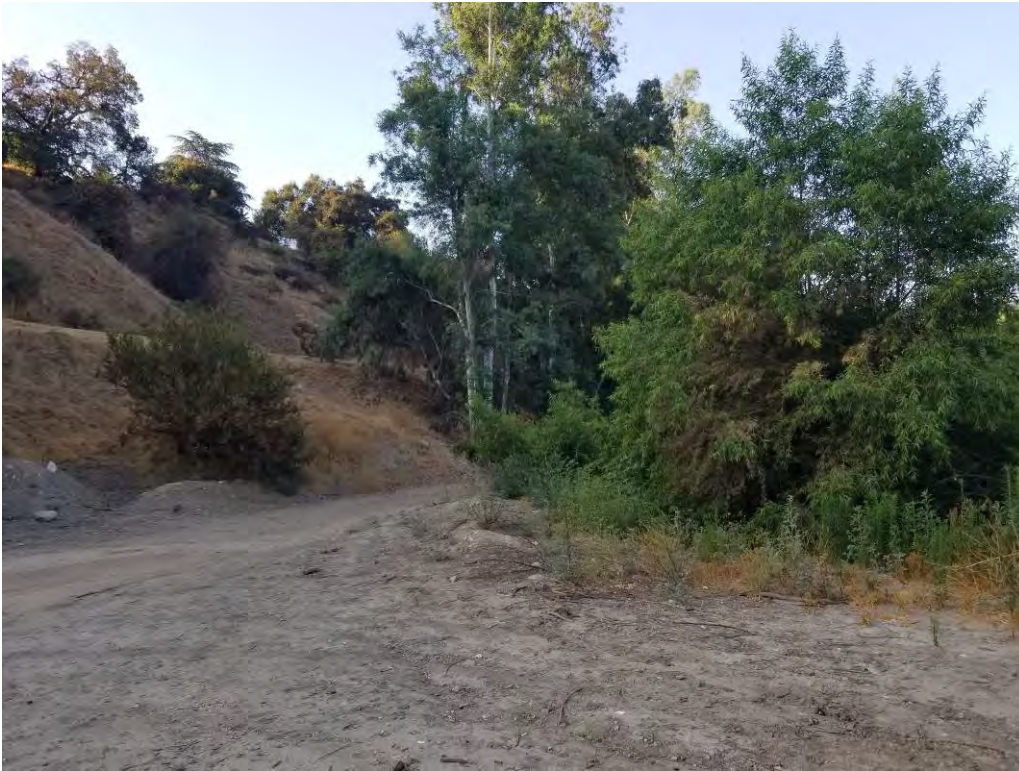
The Biological Monitor took before and after photographs of the area around the West Altadena Drain on the December 10, 2018, which was the day the vegetation removal occurred. However, the photographs taken on that day were not from the same location or direction. At the request of the USACE, ECORP took additional photographs of the after condition at the West Altadena Drain from the same locations and directions as the before photographs. The new after photographs were taken on February 25, 2019, which was after multiple large storms created flows that scoured the area around the West Altadena Drain. The photographs are included as Attachment 2 to this memorandum. Photographs 1 and 2 show the vicinity of the West Altadena Drain looking south towards Devil's Gate Dam and photographs 3 and 4 show a close-up of the West Altadena Drain looking northwest.

Photograph 1 – West Altadena Drain area prior to clearing (on left of photo)

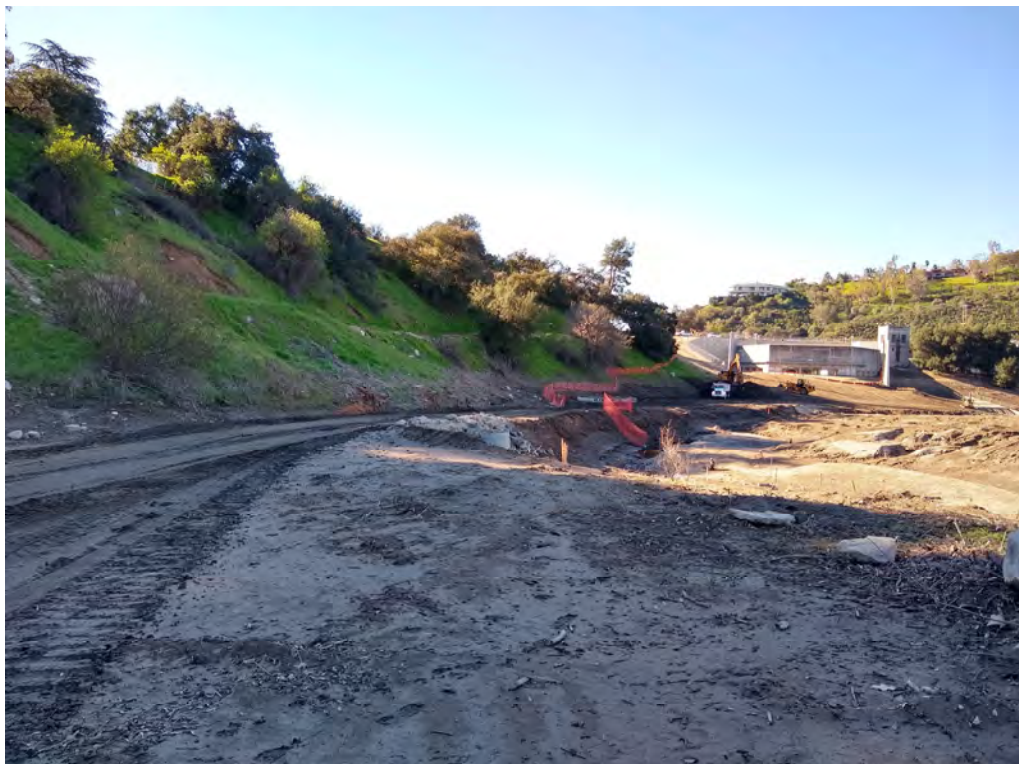
Photograph 2 – West Altadena Drain area after clearing

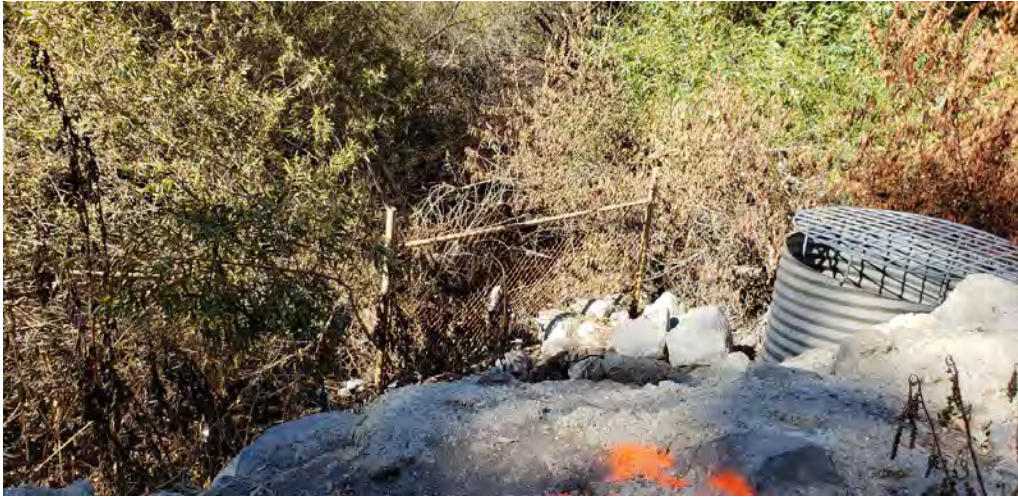
Photograph 3 – Close-up of habitat around West Altadena Drain prior to clearing

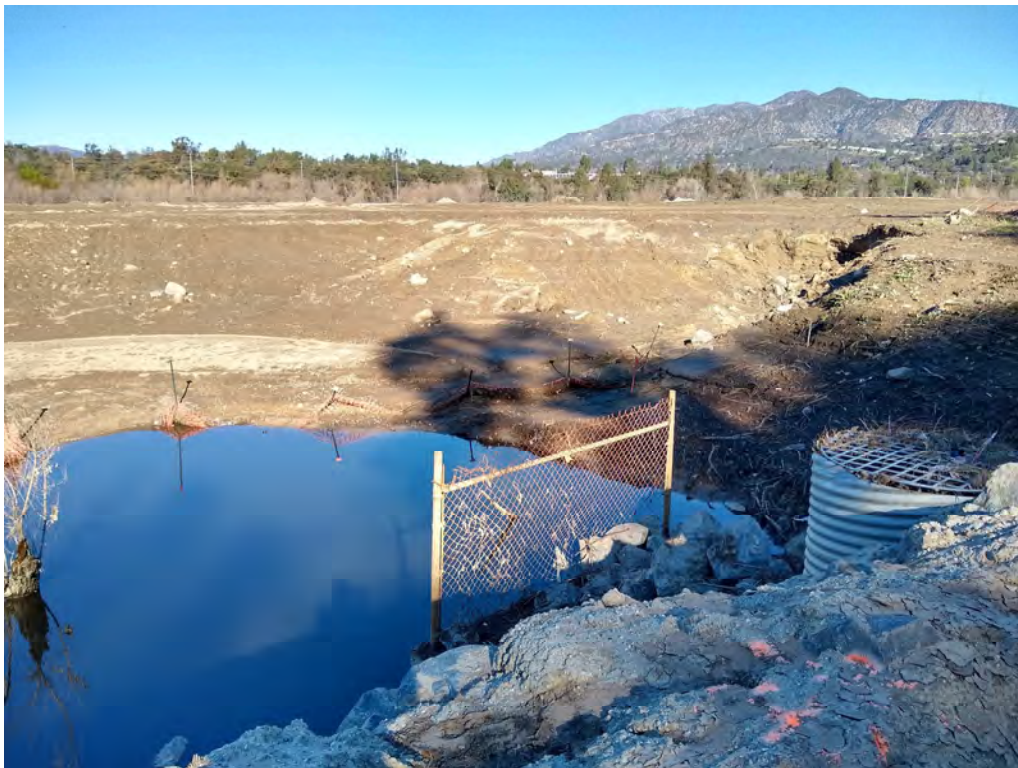
Photograph 4 – West Altadena Drain after clearing

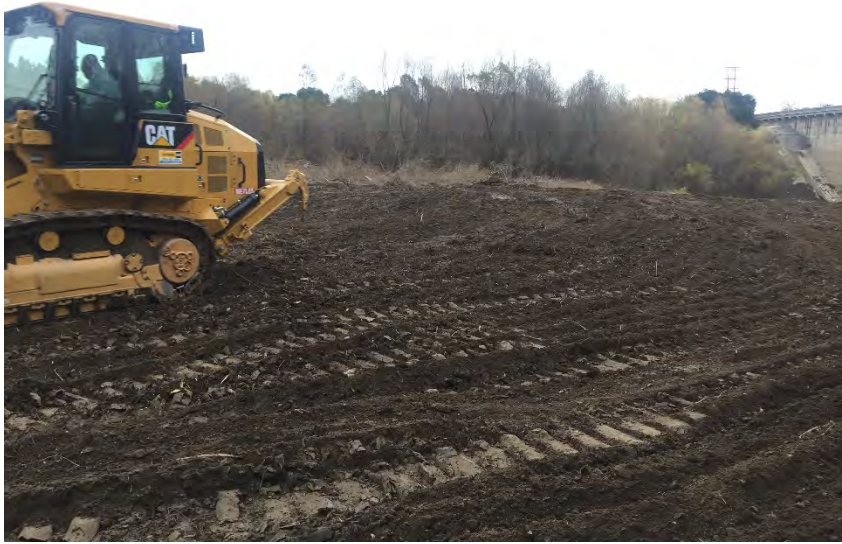
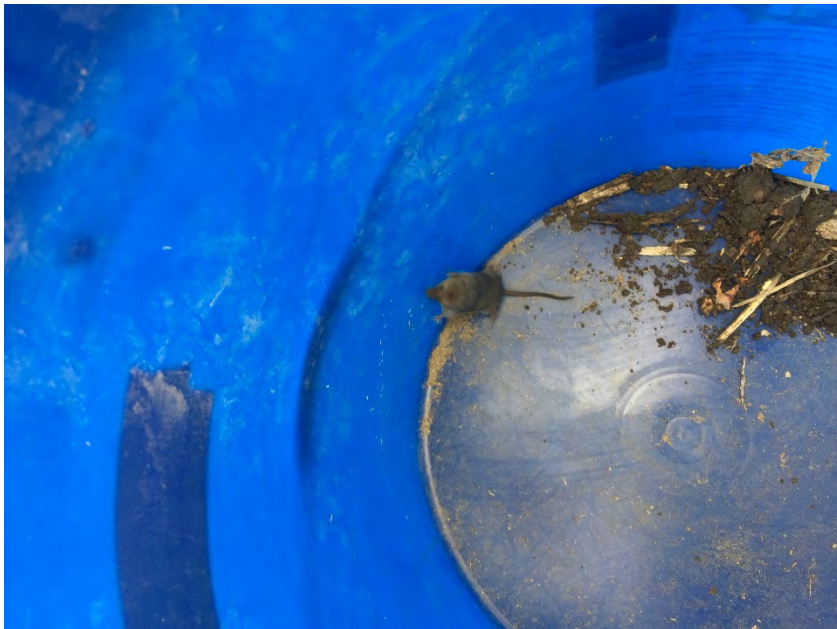
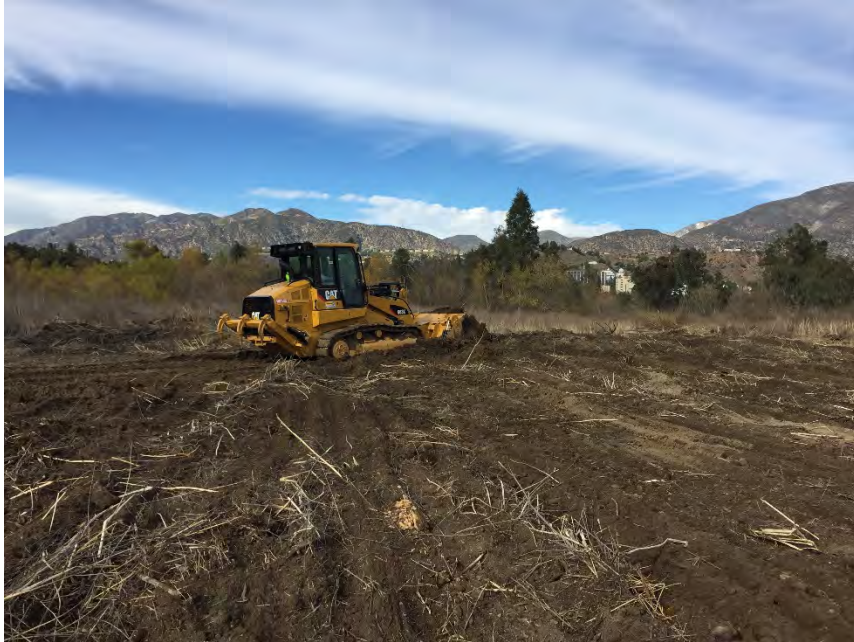
Resume activities 1200 Relocated 2 shrews, 1 deer mouse, 2 king snakes, 1 gopher snake, 2 alligator lizards, 1 western fence lizard, 1 side-blotched lizard. Veg clearing continued until 1630
