Memorandum

To: Christine Medak, USFWS
Project: Devil's Gate Reservoir Restoration Project
From: Lauren Simpson
Date: June 18, 2020

Subject: Weekly Least Bell's Vireo Survey and Noise Monitoring Summary for the Devil's Gate Reservoir Restoration Project; Week of June 8 – June 12, 2020

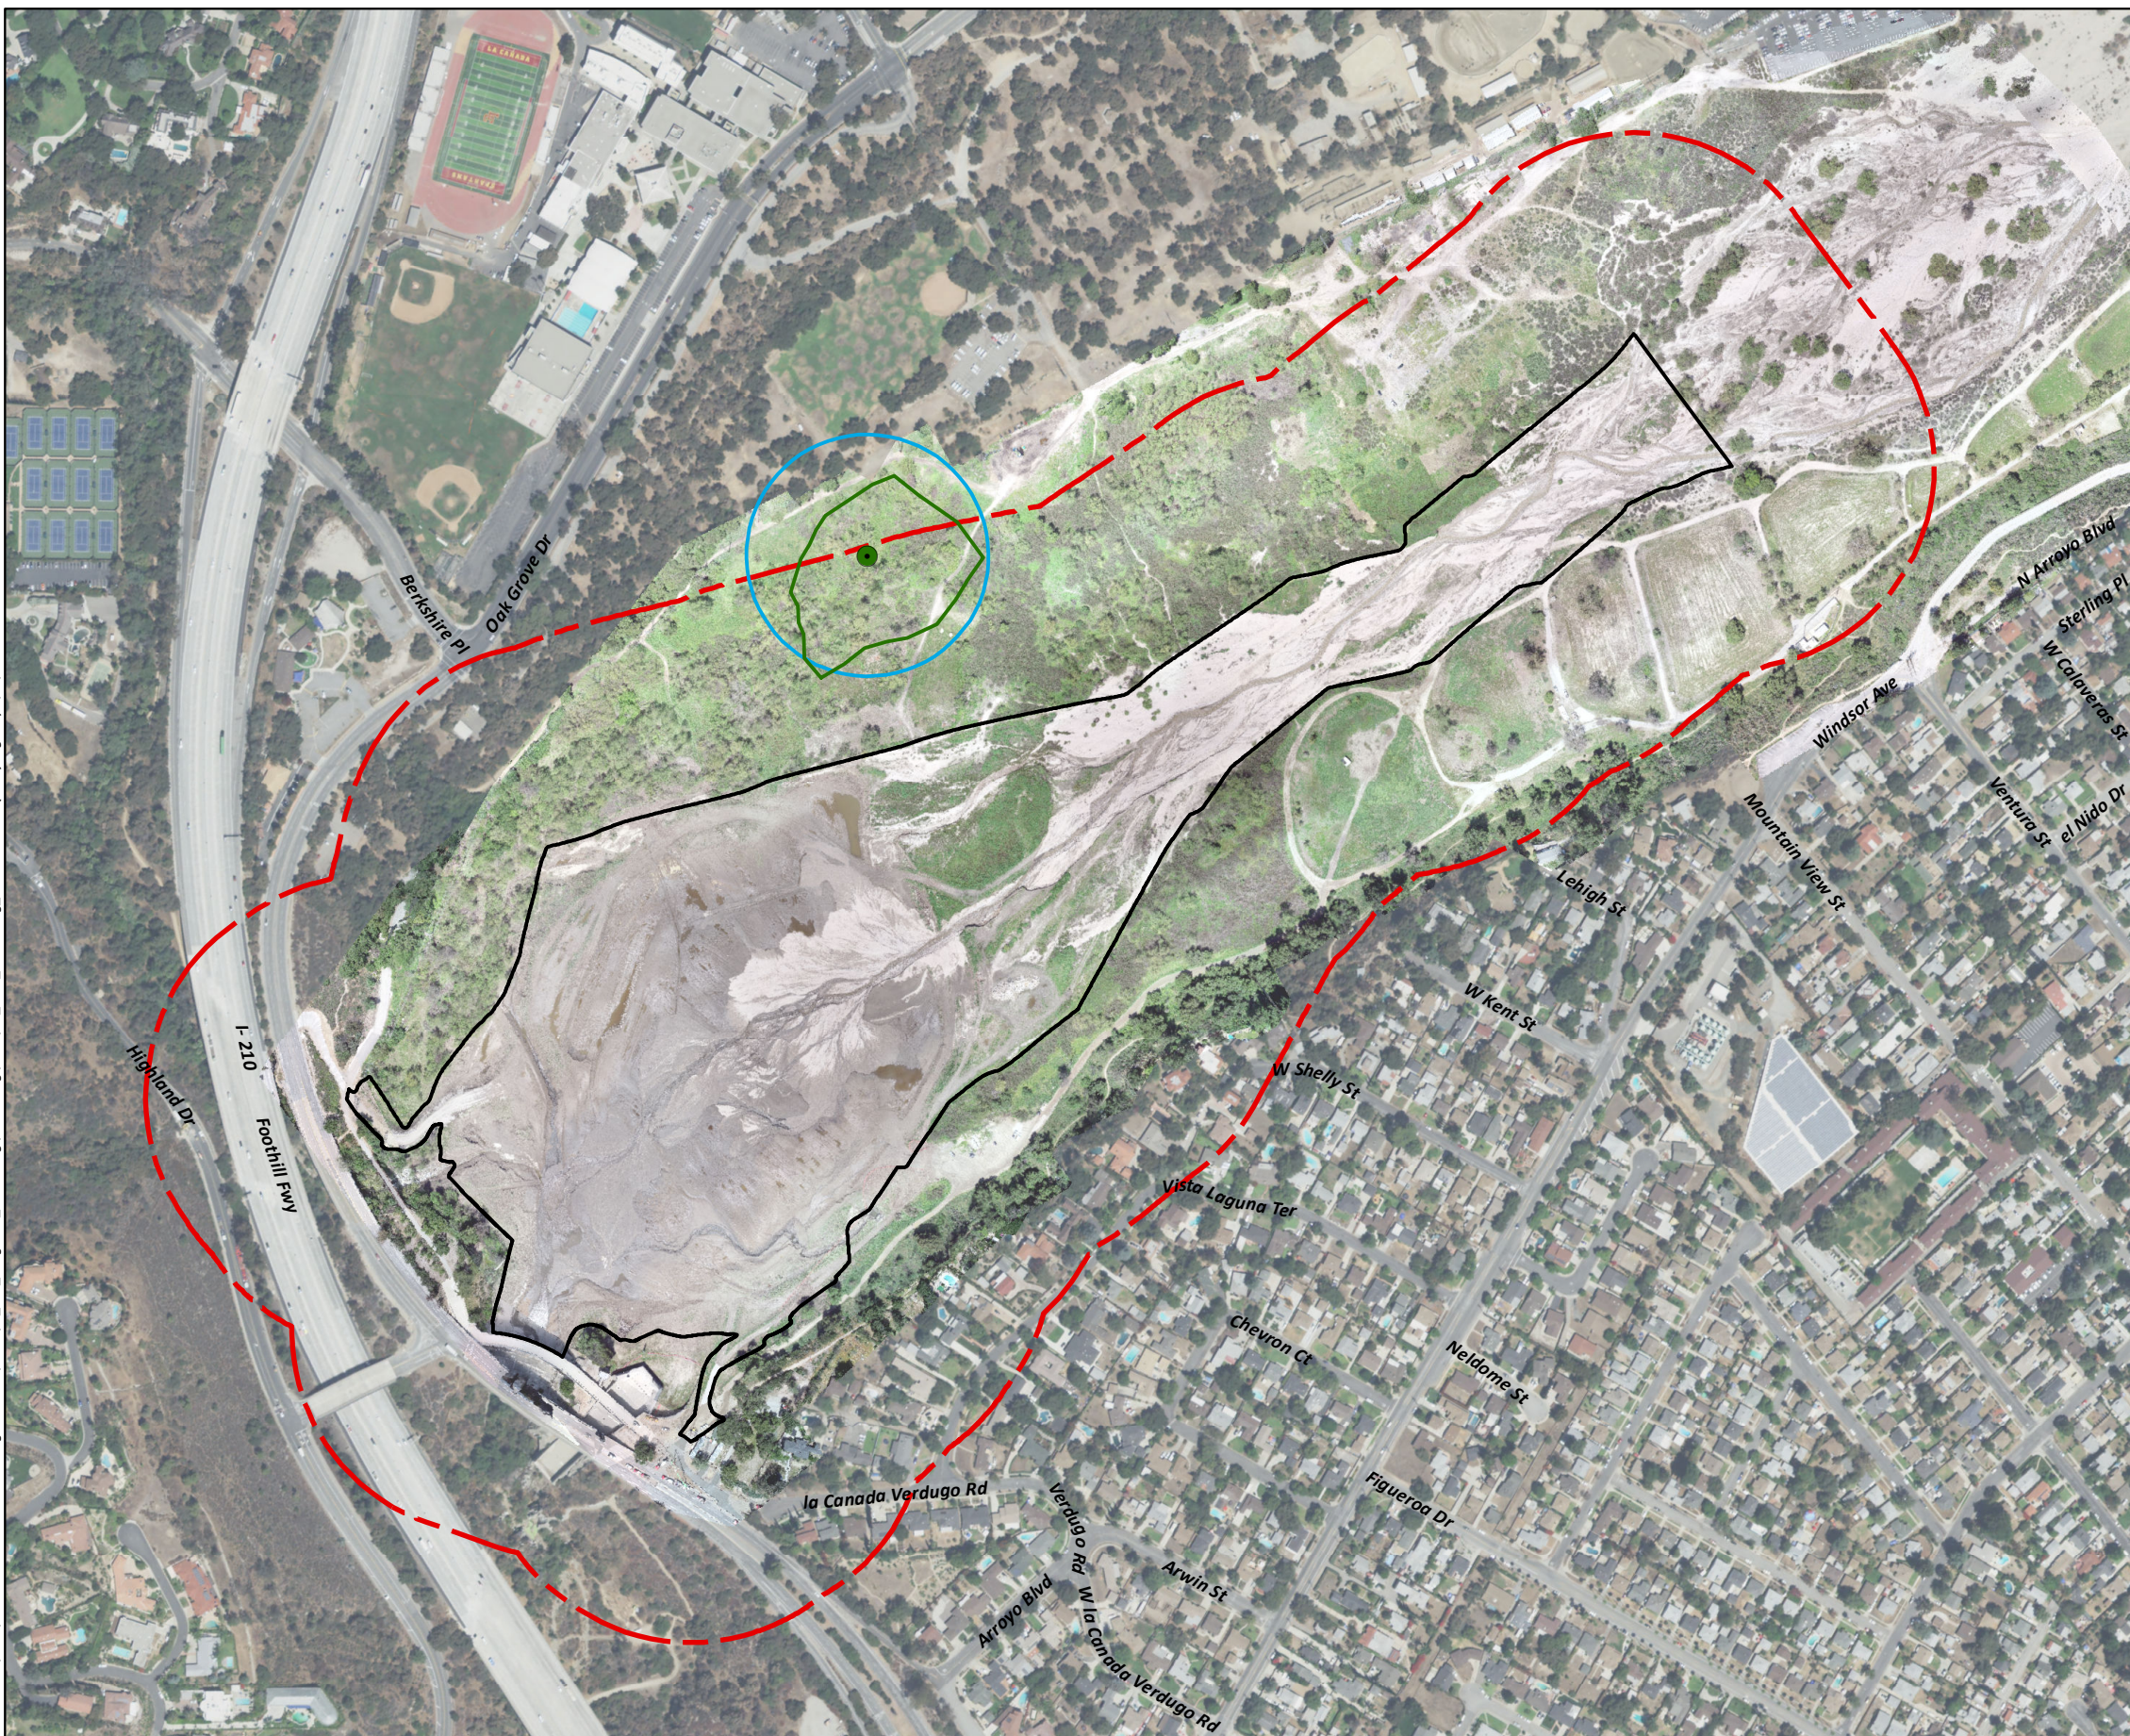
Figure 1.
Least Bell's Vireo Monitoring
June 8 - 12, 2020

The least Bell's vireos were documented during both surveys conducted during the week of June 8, 2020. The location of the least Bell's vireo nest and territory are depicted in Attachment A. The male was observed singing within the previously documented territory as well as further east than was previously documented. The territory size was expanded to reflect these observations. The Designated Biologist observed the nest on June 8, 2020 after the female vireo briefly left the nest. Four nestlings were observed within the nest. The nestlings appeared to be 7 to 8 days old and close to fledging (which typically occurs at 12 days). During the survey on June 12, 2020, the Designated Biologist observed the nest and determined it to be empty.

Begging fledglings were heard in a mulefat shrub close to the nest location and the male and female least Bell's vireo were active in the area. The least Bell's vireo nest was determined to have successfully fledged as of June 12, 2020. The 300-foot buffer will remain in place around the nesting location until the fledglings are independent of the pair and no additional signs of nesting are observed by the Designated Biologist.

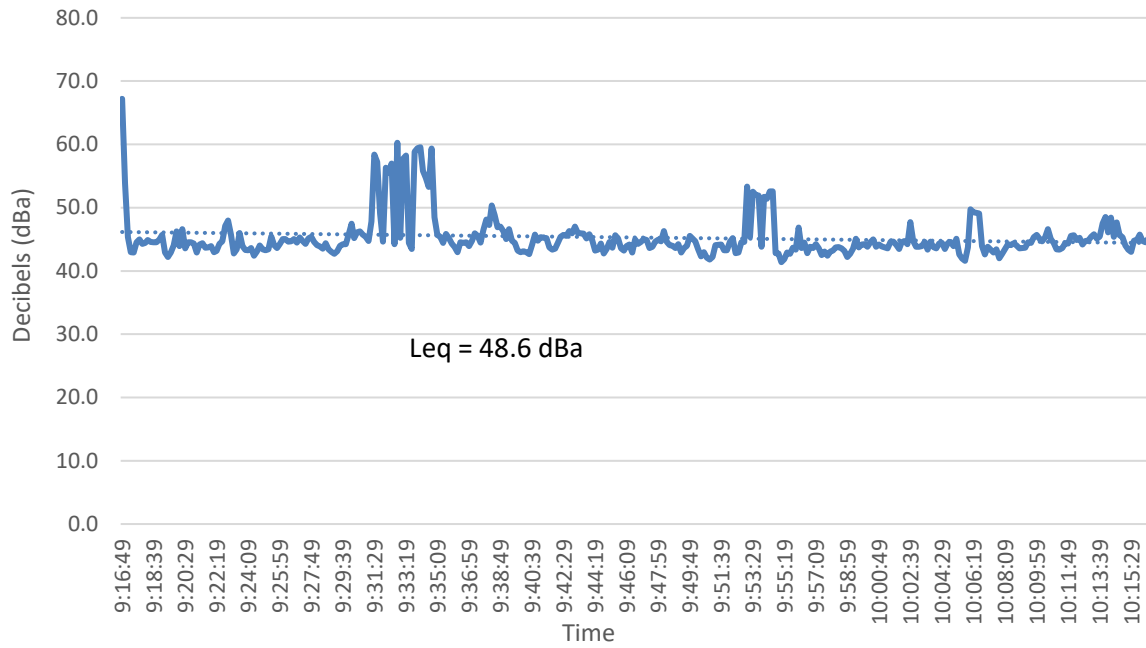
Devil's Gate Reservoir Restoration Project:
LBVI SM3 Leq June 10, 2020

Noise monitoring for the week of June 8, 2020 occurred on June 10, 2020. A noise monitoring station was established no less than 100 feet from the active least Bell's vireo nest under the direction of the least Bell's vireo Designated Biologist. Noise monitoring for Project activities occurred between 7:07 am and 3:31 pm. The monitor ensured that all construction hourly noise levels (Leq) remained below 60 dBa. All hourly Leq measurements were below 60 dBa during the noise monitoring (see Attachment B). Instances where noise levels momentarily exceeded 60 dBa were attributed to the movements of the noise monitor in close-proximity to the noise meter at the start of each hour to program the meter for hourly measurements and to low-flying helicopters that passed above the site regularly throughout the day due to the close proximity of a helicopter landing pad southeast of the Project site.
